SERVICE BULLETIN No.33 SKY INTERNATIONAL INC.

AIRCRAFT: All PITTS S-1 and S-2 series

Bulletin No.: PRS-107

SUBJECT: HEX PLUG 383493 COMING LOOSE FROM REGULATOR COVER

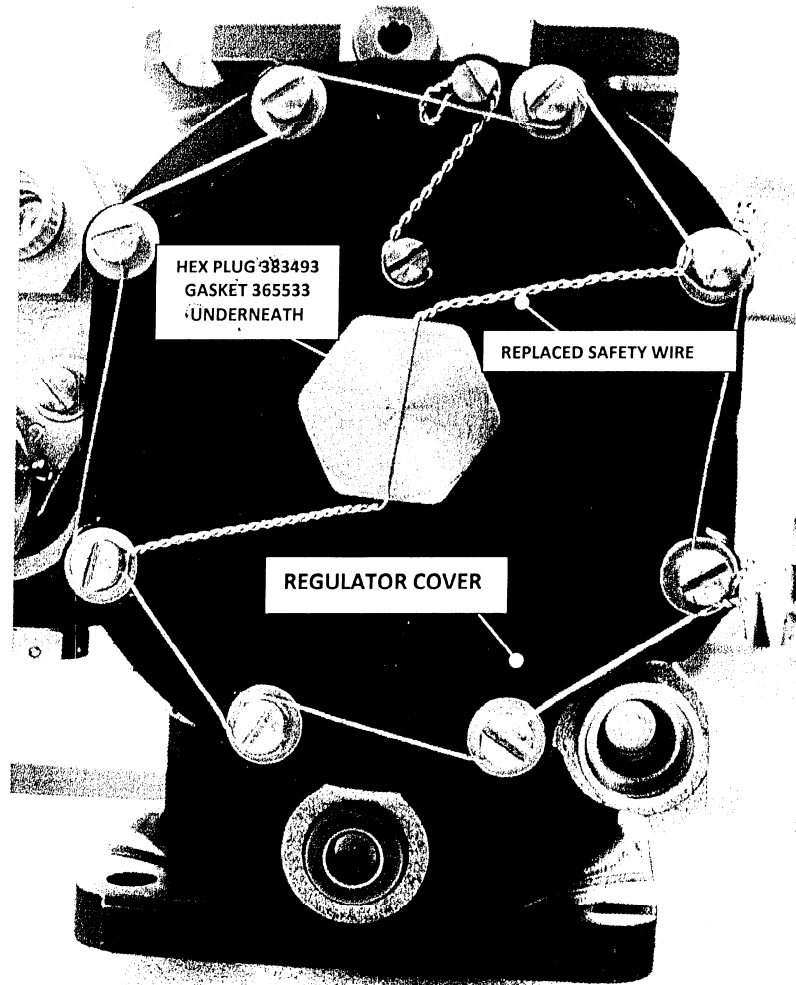
Note: Plug safety wire is wrapped around regulator screws under existing wire. It does not go through the holes in the screws.

7. The hex plug must be safety wired with .025 inch diameter wire to the regulator cover as shown in the figure below. The wire shall pass thru the plug such that it pulls the plug in the tightened direction and does not touch the corners of the hex on the plug.
