# SERVICE BULLETIN

## PITTS SPECIAL

**SERVICE BULLETIN - NO. 19**  
Engineering Aspects are  
FAA approved.

Oil Breather Line

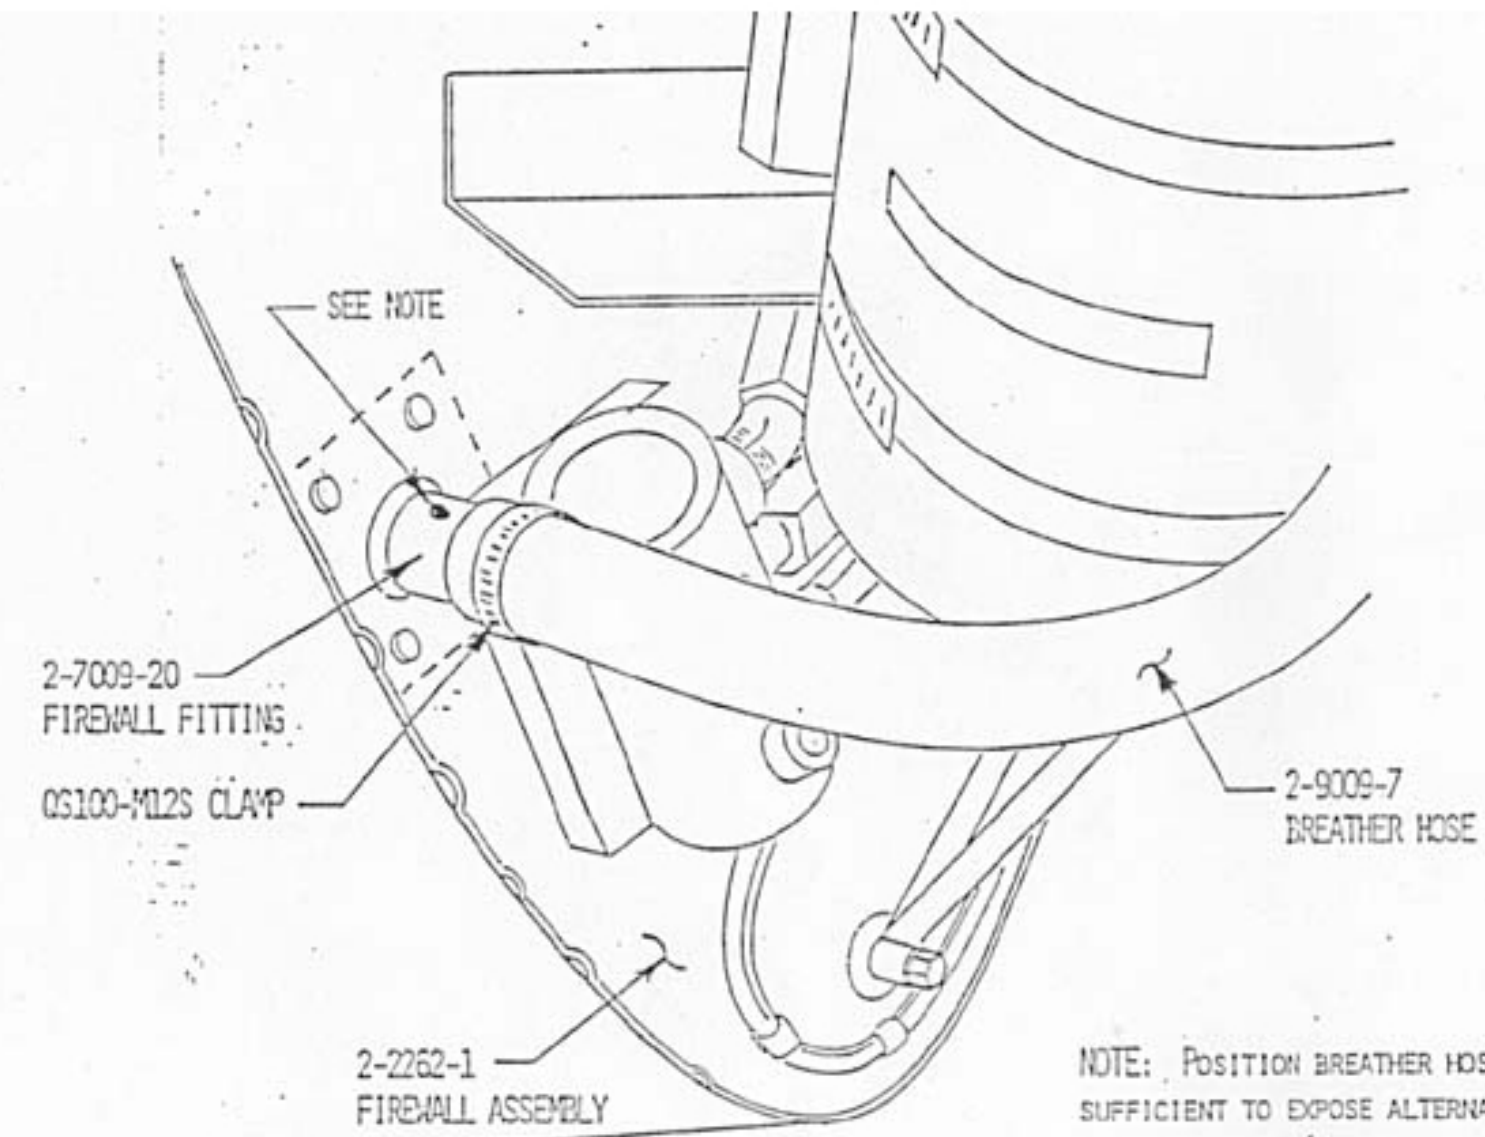
It has recently been reported to us that a Pitts Special S-2B manufactured in 1987 by Christen Industries, Inc. suffered a rapid loss of engine oil and an off airport landing due to blockage of the Oil Breather Vent at the rear of the aircraft with ice.

Although the aircraft is prohibited from flying in known or forecast icing conditions this Service Bulletin requires all owners to ensure that the Oil Breather Tube located on the forward side of the firewall is pulled forward sufficiently to insure that the secondary breather hole is exposed to allow pressure release in the event of blockage by ice of the tail outlet of the breather tube (see illustration).

The company is investigating a more convenient solution but no problem will exist if the breather hose is positioned forward of the secondary breather hole to prevent any pressure buildup in the breather system.

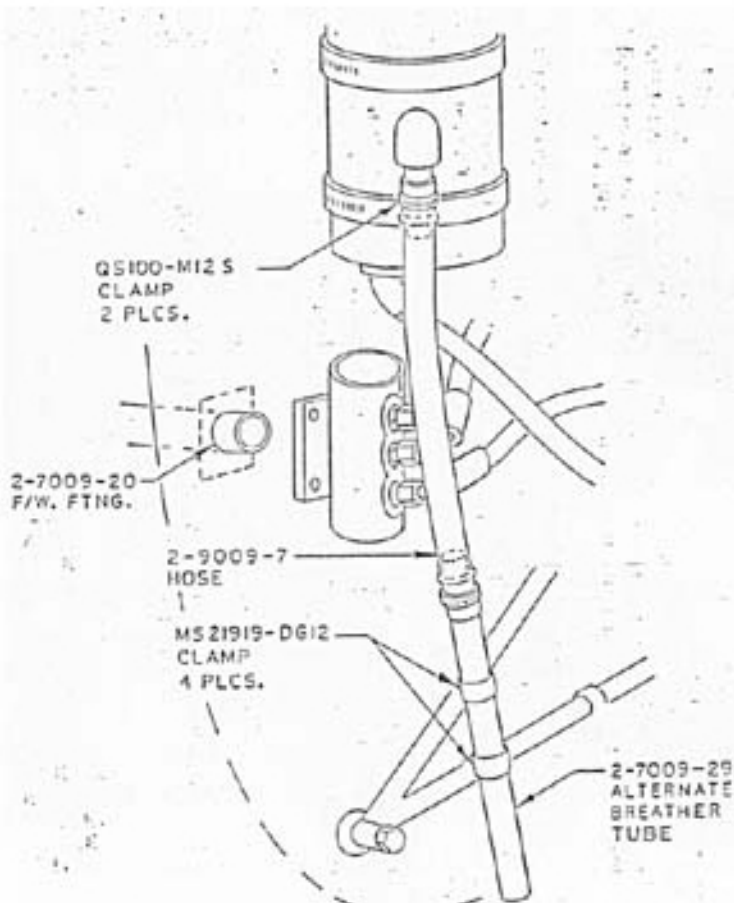
FIG. NO. 1

Two methods of providing alternate breather venting have been used on various Pitts models. On the early serial number S-2, S-2A, S-1S, and S-1T a separate tube (S-2, S-2A P/N 1-604-43 and S-2, S-2A P/N 2-7009-29) was attached to the engine mount and vented above the right hand exhaust stack through the lower cowl cooling air opening. This method and the means for retrofitting was described in Pitts Aviation Enterprises, Inc Service Bulletin No. 2, dated Dec 27, 1971. When operation in freezing conditions was anticipated the breather hose from the oil separator was disconnected and reconnected to the alternate tube and secured. (FIG 1)

All Pitts owners, whether factory built or kit built, using an inverted oil system with aft venting breather lines should verify that one of these two methods of alternate crankcase venting exists on their aircraft and is open, especially during long flights or cold weather operation.

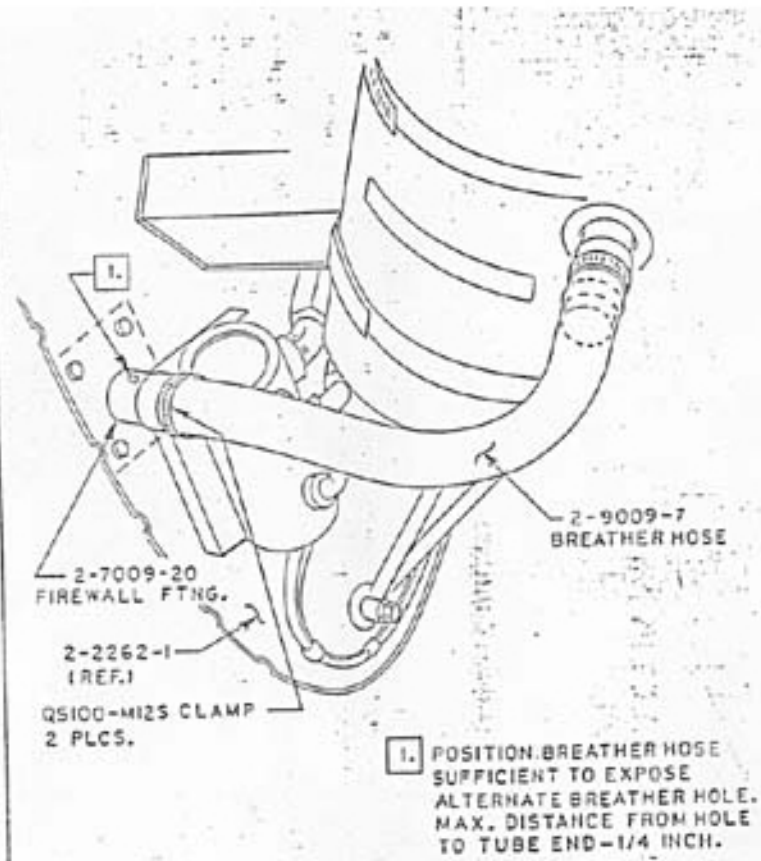
FIG. NO. 2

Later S-2A, S-1T, S-2S, and S-2B aircraft have a 9/64 hole drilled in the upper forward side of the firewall fitting (S-1S, S-1T P/N 1-604-40 and S-2S, S-2B P/N 2-7009-29). It is essential that this alternate vent hole remain uncovered in freezing conditions. The breather hose from the oil separator should be pulled forward to expose the vent hole. (FIG 2) If a vent hole is not present one can be drilled using a minimum 9/64 drill.
