## SERVICE BULLETIN

### PITTS SPECIAL

**DATE:** April 1993      **SERVICE BULLETIN - No. 20**  
Engineering Aspects are  
FAA approved.

**SUBJECT:**                      Ammeter Fluctuation

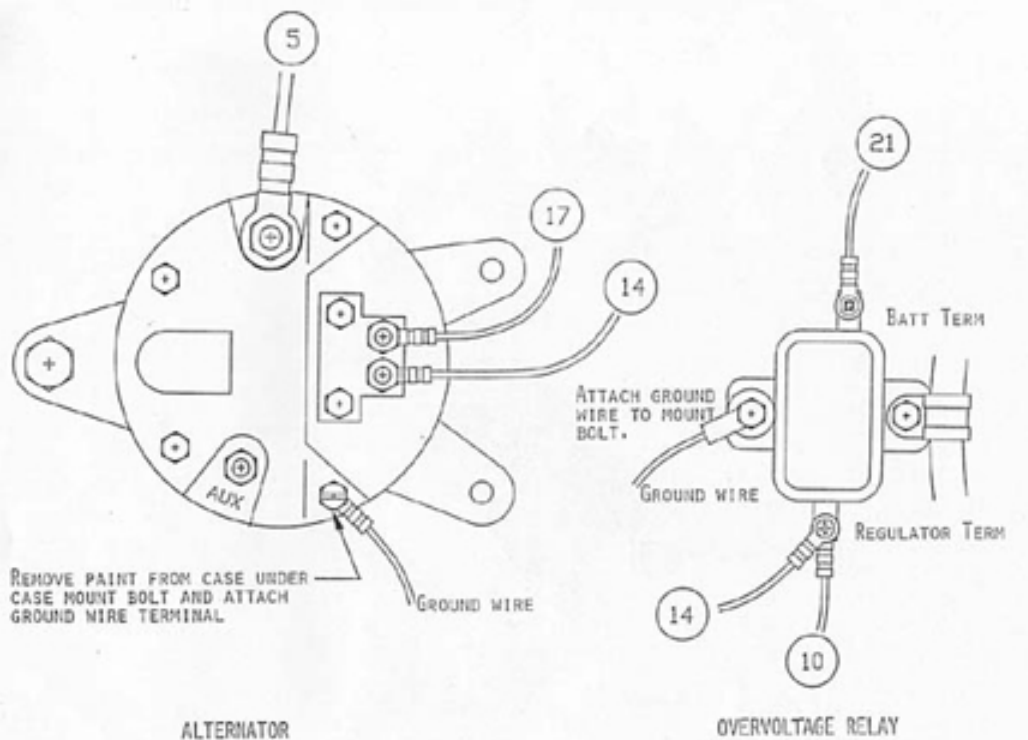
FIGURE 1.

It has been reported that some aircraft equipped with the ElectroSystems Inc. VSF7203A Voltage Regulator and OS75-14 Overvoltage Relay have been experiencing a continual fluctuation or pulsing of the ammeter needle when the alternator is on line. The cause may be the sensitivity of the VSF7203A to a difference in ground potential between it and the alternator. This difference in potential results from degradation of the ground path between the units. This can be caused by a buildup in oxides, dirt, oil, etc., between ground path contact points such as engine ground strap to frame.

Aviat has been advised by ElectroSystems Inc. that in most cases the fluctuation can be eliminated by wiring a direct ground connection between the alternator case and the overvoltage relay ground. (See Figure 1.) Use a minimum #18 AWG wire, length 53 inches with Sta-Kon 18RA-8 terminals or equivalent on each end. Route additional wire through the existing wire bundle.

If this does not cure the problem the OS75-14 Overvoltage Relay is suspect and should be replaced.
