## SERVICE BULLETIN

## PITTS SPECIAL

SERVICE BULLETIN - No. 21

Manifold Absolute Pressure Line Re-route

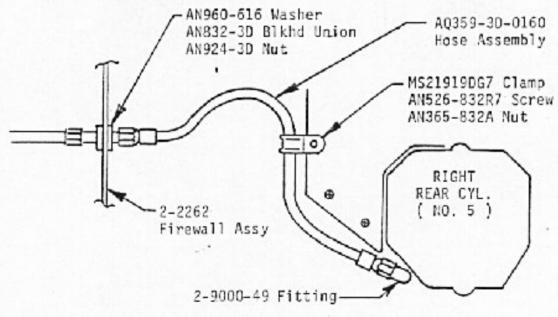
MANIFOLD PRESSURE HOSE RE-ROUTE

There have been reports of Manifold Pressure Gauges being contaminated by residual fuel which finds its way into the manifold pressure line. The source of this contamination may be overpriming or seepage of raw fuel after shutdown. On recent production aircraft, the MAP line routing has been changed to remove a low point in the hose and a restrictor fitting has been added. (See Figure 1.)

Owners of Pitts Special aircraft may also wish to re-route the MAP line to eliminate the possibility of fuel collecting in the low point. Kit # S-2B-517, which contains the new restrictor fitting and the hardware required to accomplish the line re-route, is available from Aviat Inc.. Contact Aviat Parts Department, 307-886-3151, for price and availability.
