## SERVICE BULLETIN

### Pitts S-2B

SERVICE BULLETIN NO. 26

SUBJECT: Throttle and Cowl Flap Control Cables  
P.N. 60534 & P.N. 60526

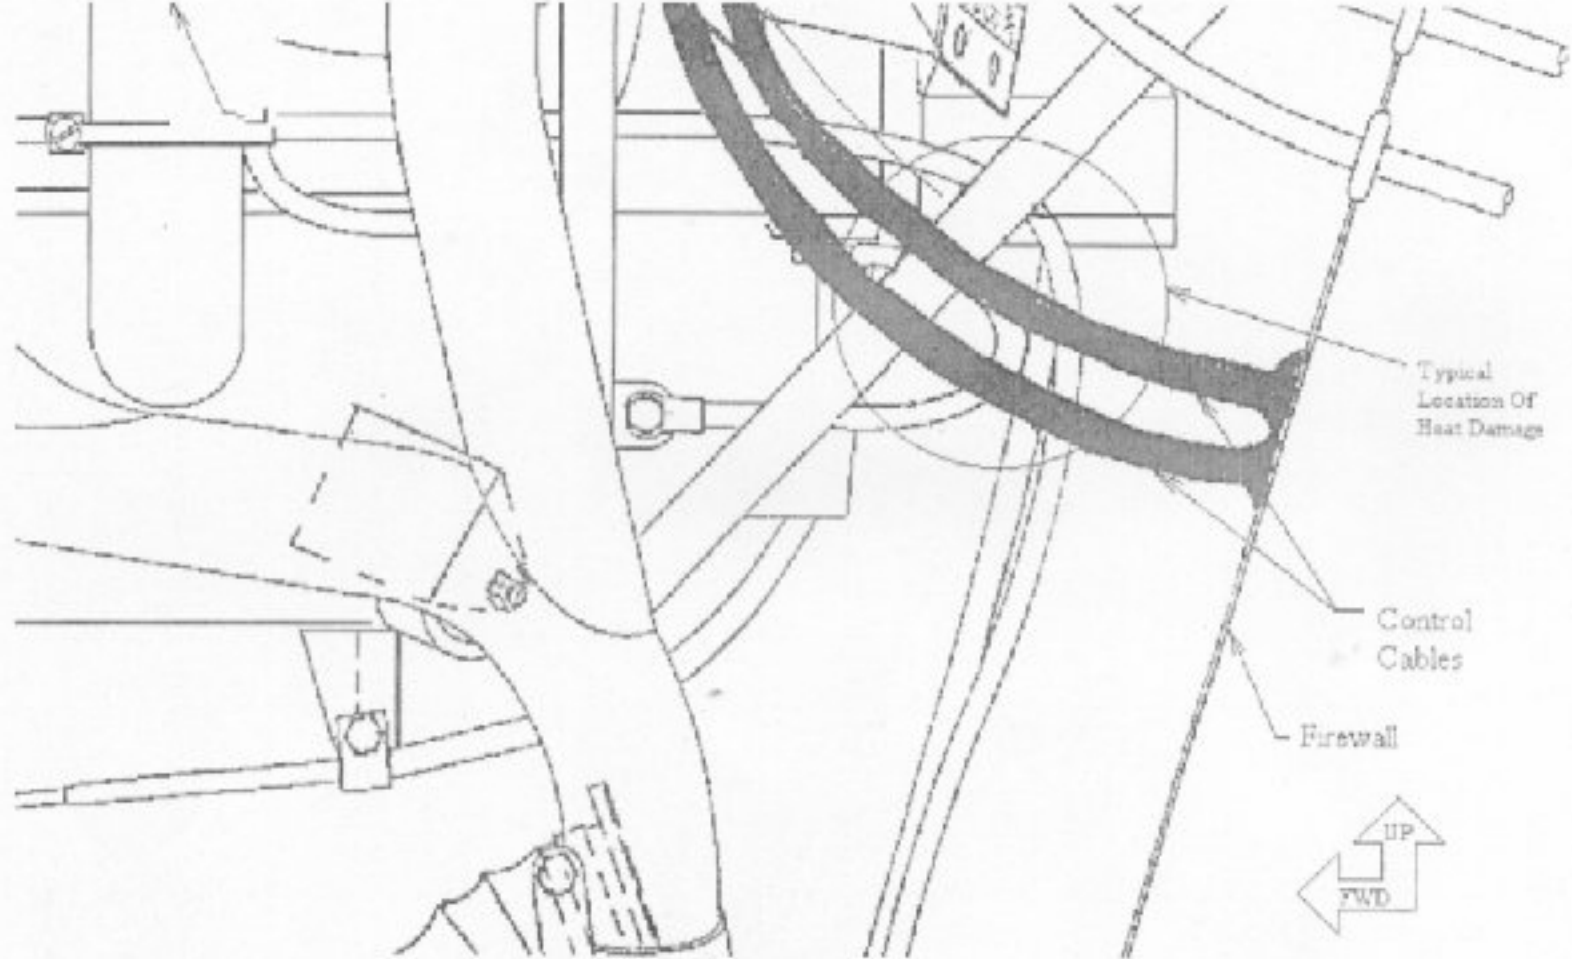
Figure 1

There have been reports of the outer plastic shell of the control cables melting just forward the firewall. This problem can only occur on aircraft S/N 5286 and up, due the proximity of the cables to the exhaust manifold. This is probably due to heat radiating from the exhaust manifold after engine shut down. See Figure 1.
