SERVICE BULLETIN NO. 4

1. APPLICABILITY: ACCOMPLISIEMENT OF THIS SERVICE BULLETIN IS MANDATORY, PRIOR TO 21 MAY, 1972. This service bulletin applies to all Pitts Aviation Enterprises Model S-2A airplanes from serial no. 2001 through and including serial no. 2022. (This change on airplanes serial no. 2023 & up will be accomplished at the factory.)

SERVICE BULLETIN NO. 4
(MANDATORY)

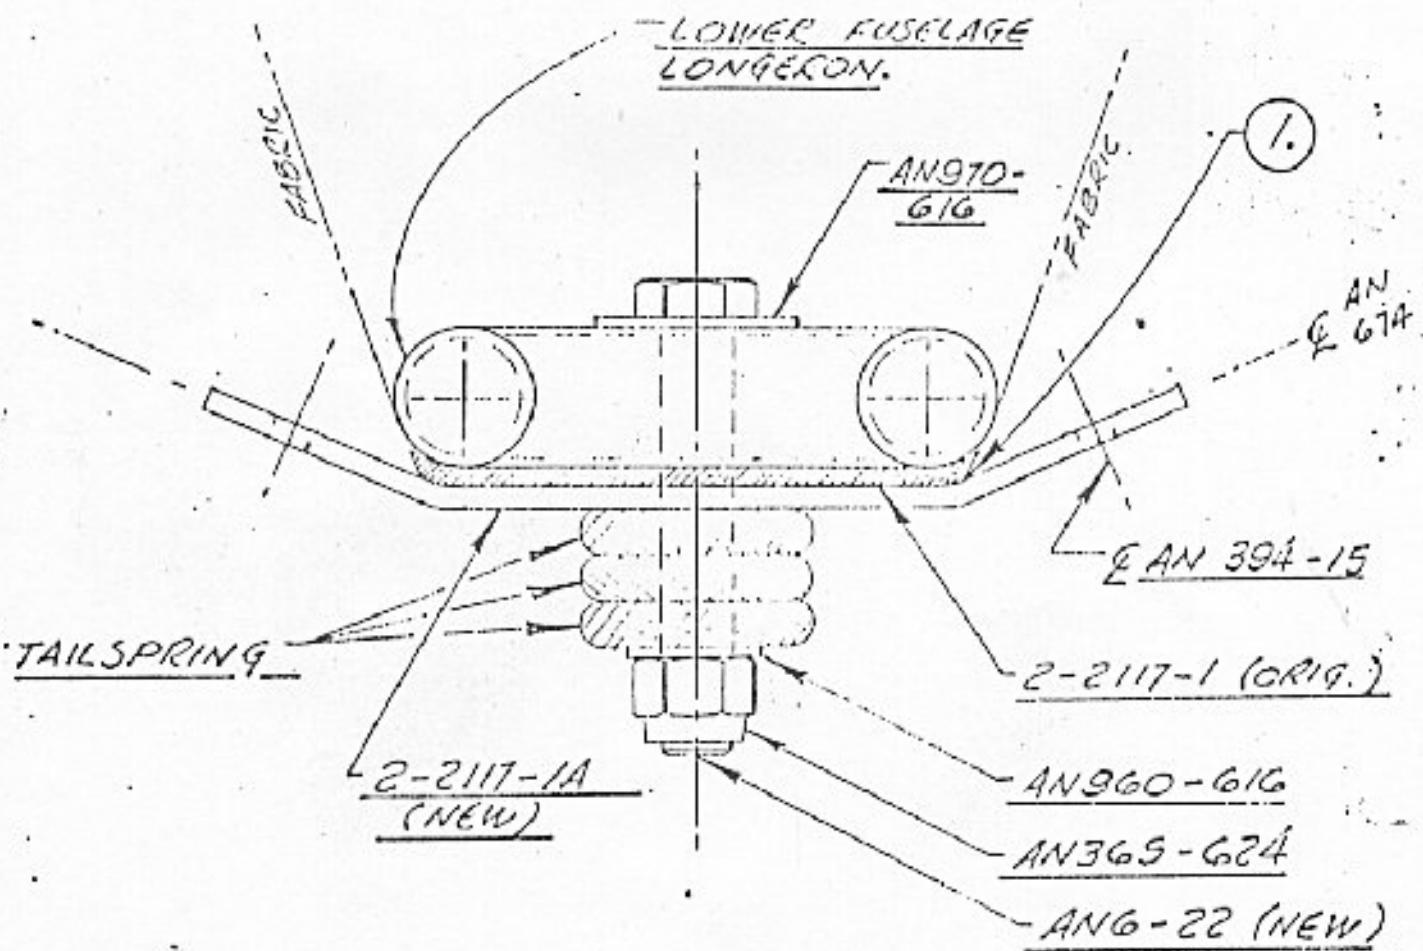
FIG. 1.

2. PURPOSE: To preclude failure of the horizontal stabilizer lower brace wire attachment to the fuselage.
3. DISCUSSION: A failure of the part no. 2-2117-1 "strap-stabilizer brace" has been brought to our attention. The failure occurred at the weld of the strap to the fuselage lower longeron. Although we believe this occurrence to have been an isolated case, we are making the following change mandatory.

NOTE ①: RADIUS LOWER EDGE OF CUTOFF APPX. $\frac{1}{32}$

- g. Cut off the two tabs on the existing 2-2117-1 strap as close to the fuselage longerons as convenient.
Note: 1. Do not damage the longerons;
2. The upward-sloping portion of the tab must be removed completely;

3. Smooth all rough edges;
4. Prime the exposed metal surfaces.
 - h. Install the new 2-2117-1A strap supplied with this Bulletin on top of the remaining portion of the old strap, using the new AN 6-22 bolt, (supplied also), and sandwiching the 2-2117-1A strap between the fuselage structure and the tailspring assembly.

- i. Run up snug but do not tighten all three tailspring bolts.
 - j. Re-attach the two An 67⁴ wire lower ends to the 2-2117-1A lugs, using the same hardware as step (e) above with a new cotter pin, and re-tighten the wires, to the same tension as before they were loosened in step (e) above.

- k. Tighten all three tailspring attach bolts. (Torque all three bolts to 80 to 100 in.lb.)
 - l. Reinstall the access plate.
 - m. Check for security of all items.
