# PITTS AVIATION ENTERPRISES, Inc.

## SERVICE BULLETIN NO. 8

**APPLICABILITY:** This service bulletin applies to Pitts Model S-1S airplanes from Serial No. 1-0001 through 1-0025. Serial No. 1-0026 and up will be modified at the factory, as will replacement wings S/N K013 & up.

**PURPOSE:** To inspect the upper wing leading edge for failed leading edge ribs and if failed leading edge ribs are found, to repair them acceptably. Compliance with this service bulletin is mandatory.

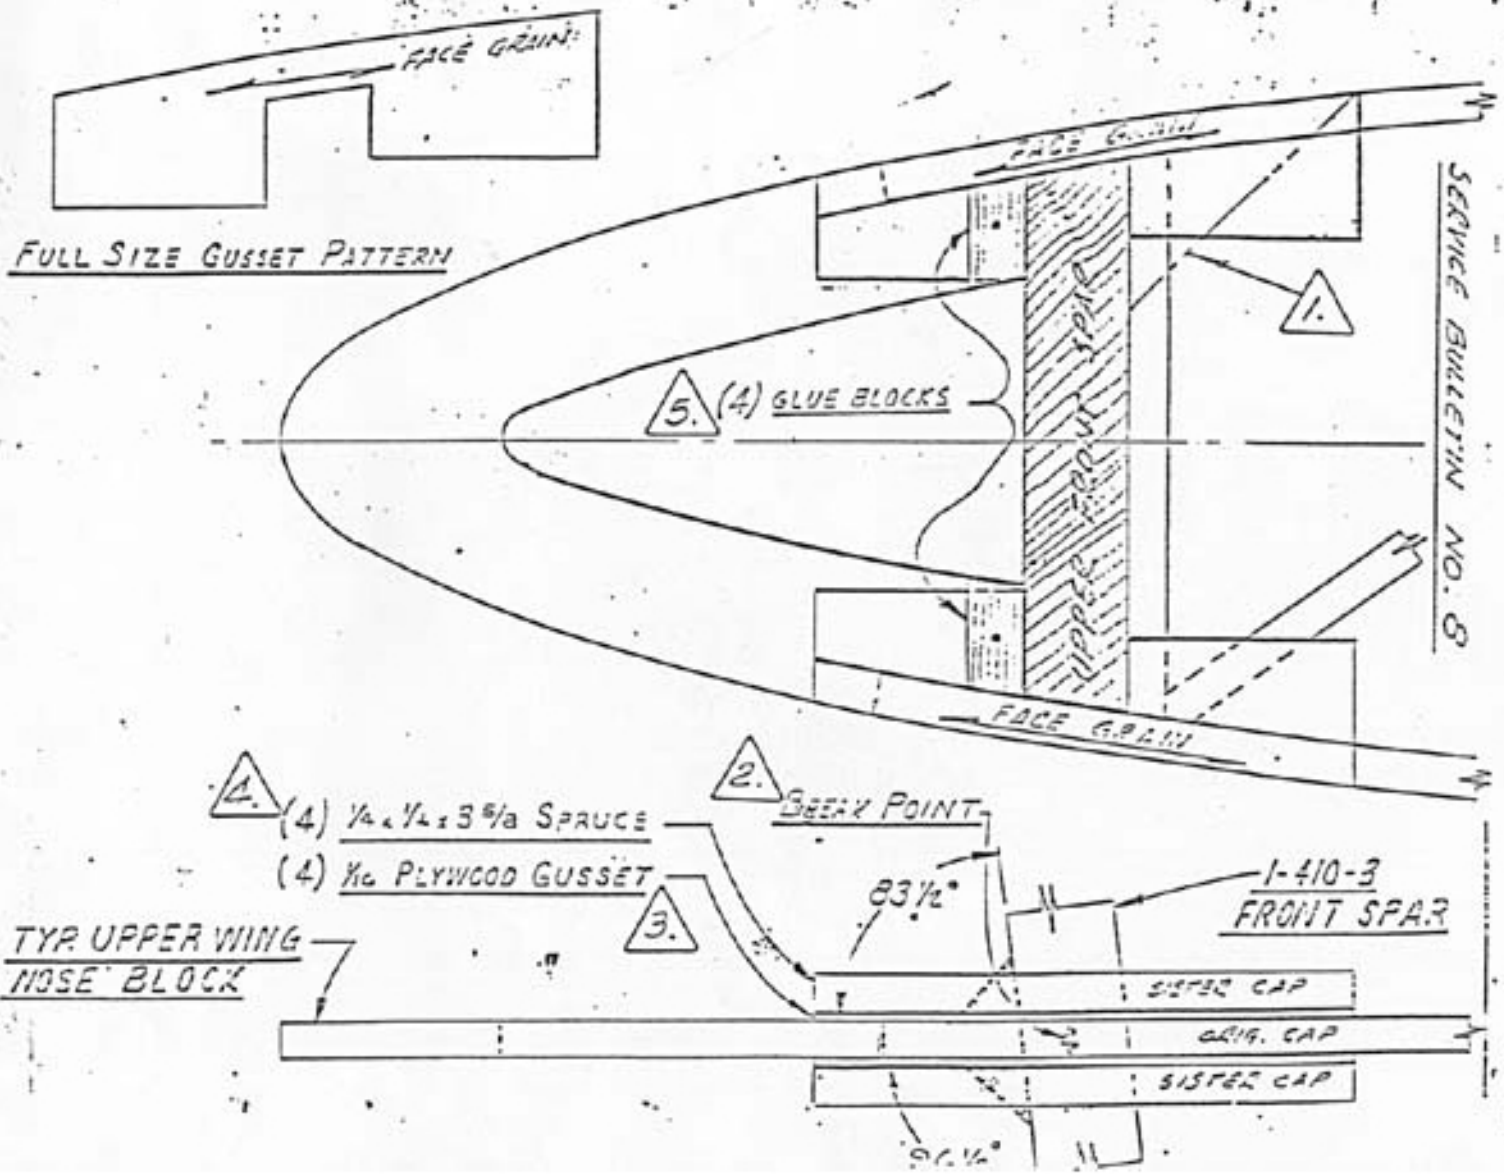
**DISCUSSION:** Failed leading edge ribs have been noted in the upper wings of airplanes which have been repeatedly flown to or beyond the limits of the design speed-acceleration envelope.

1. Remove existing plywood gussets, eight places each rib. (See note 6.)
2. Do not "clean up" fracture - push fibers back together and glue. Glue to be Weldwood Plastic Resin Glue. Manufacturer's instructions for use must be followed. All varnish must be removed from surfaces to be glued.

3. Mahogany/poplar/mahogany plywood per MIL-P-6070, or MIL-P-18066.
4. Spruce to be aircraft quality per MIL-S-6073.
5. Four per rib. Note bevel angles shown in lower view. Each glue block to be secured while glue dries by one 18 gage cement-coated aircraft nail, 3/4" long. Make from spruce per note 4 above. Glue faces, on rib and spar, to be 3/8" minimum width.

6. At root ribs, make repair on outboard side of ribs only. On compression ribs, 1/16" plywood filler is required to fill gap across spar between original gussets. Do not remove gussets on compression ribs - add four large repair gussets, (Shown full size, sheet 2 of 3), on top of existing gussets. Else as shown.
