SERVICE BULLETIN NO. 11

Aviat Aircraft Inc.

SUBJECT: Elevator Horn

AIRCRAFT MODEL AFFECTED: Husky A-1, A-1A, A-1B, A-1C-180 & A-1C-200

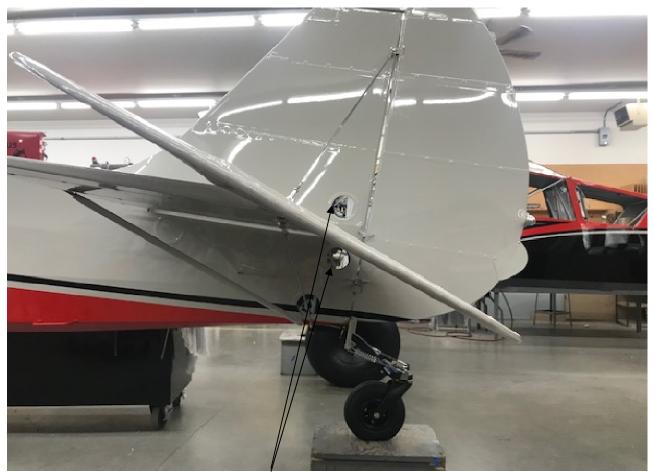
Figure 1, inspection holes

Step 1. Locate and remove the two inspection covers from the vertical tail section just above and below the elevators, see figure 1. The use of the applicable section of the illustrated parts catalog (IPC) on tail surface installation can be helpful with disassembly and reinstallation.

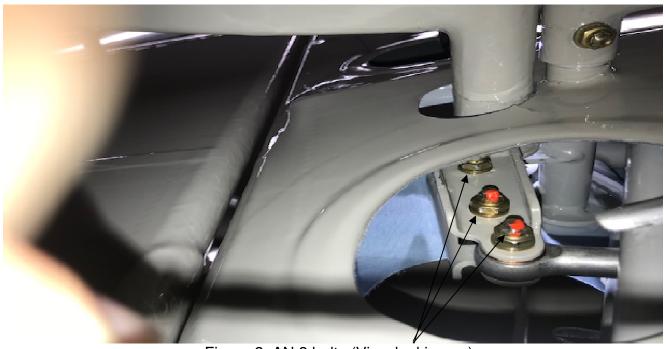
Figure 2, AN 3 bolts (View looking up)

Step 2. Remove the three AN 3 bolts from the elevator horns and the elevators will be disconnected from each other and from the elevator control rod, see figure 2.

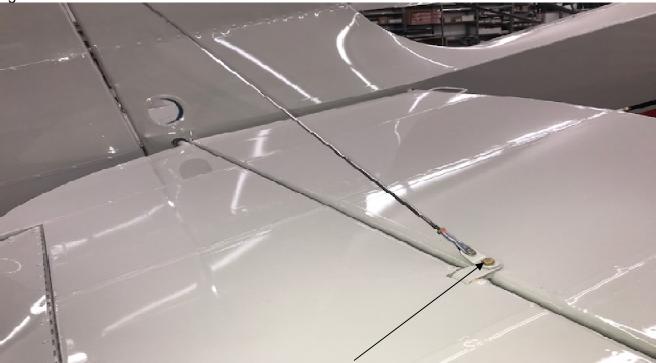
Figure 3, AN4 bolt

Step 3. Next remove the AN4 bolts holding both elevators to the horizontal stabilizers, see

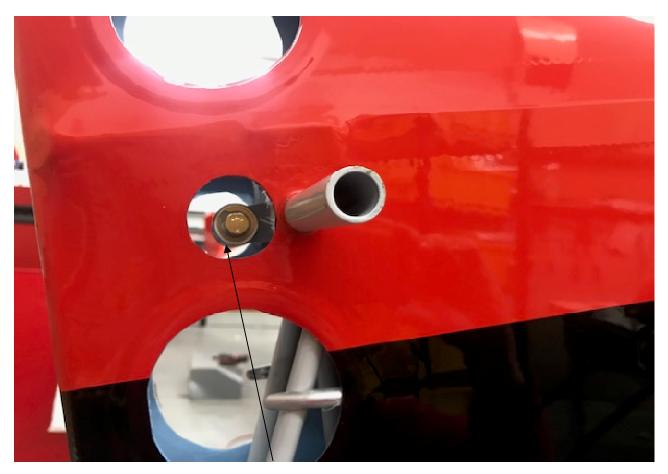
Figure 4, Elevator bearing (stabilizer removed for clarity)

Step 4. With the AN 3 and the AN 4 bolts removed the elevators can be removed from the fuselage by sliding the elevator outboard until the elevator slides off the bearing in the fuselage, see figure 4. Then tip the elevator outboard end down and remove the elevator. Care should be used when removing the elevators to avoid tearing the fabric on the fuselage with the elevator horns.

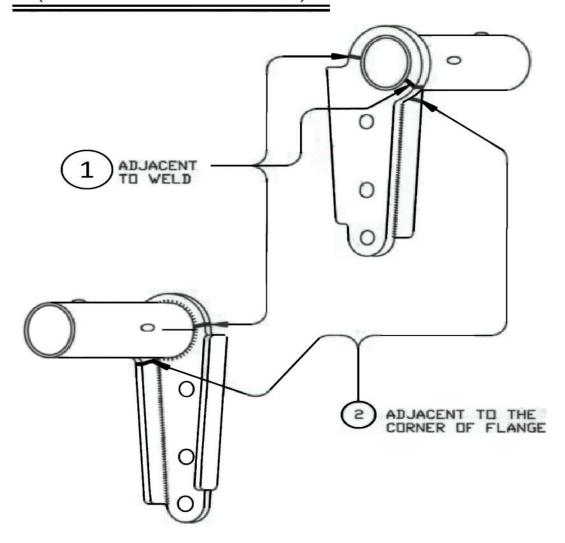
Figure 5 Elevator horn attachment to the elevator spar

Examination of elevator horn failures and a study of possible causes indicates that the failures may be due to improper rigging of the horizontal stabilizers on the aircraft. This results in a slight amount of dihedral which causes a bending load on the elevator horns when the elevator is operated through its range of travel. After enough bending cycles, a crack can be induced, and if not discovered in time, will progress until failure of the horn occurs. The elevator horn serves as an attachment point for the elevator control system.

Step 5. Inspect the elevator horns for cracks in the area of the weld attachment to the elevator spar, see figure 5. If no cracks are found in the elevator horns, the elevators can be reinstalled in the reverse order as removed. The Instructions for Continued Airworthiness can be helpful with reinstalling the elevators. All self-locking nuts must be replaced during reinstallation and all nuts should be installed using the torques values as specified by AC 43.13-1.

POSSIBLE CRACK LOCATIONS (REF: SERVICE BULLETIN 11)

If during the inspection, cracks are found in an elevator horn, the elevator horn must be replaced. In addition, the rigging of the tail surfaces must be checked to ensure that the horizontal stabilizers are not rigged with any dihedral. Rigging instructions can be found in the Instructions for Continued Airworthiness for the applicable aircraft model.
