Service Bulletin

Service Bulletin No. 1

SUBJECT: TAIL BRACE STRUT

MODELS AFFECTED: CHRISTEN A-1 HUSKY S/N's 1001 THRU 1085

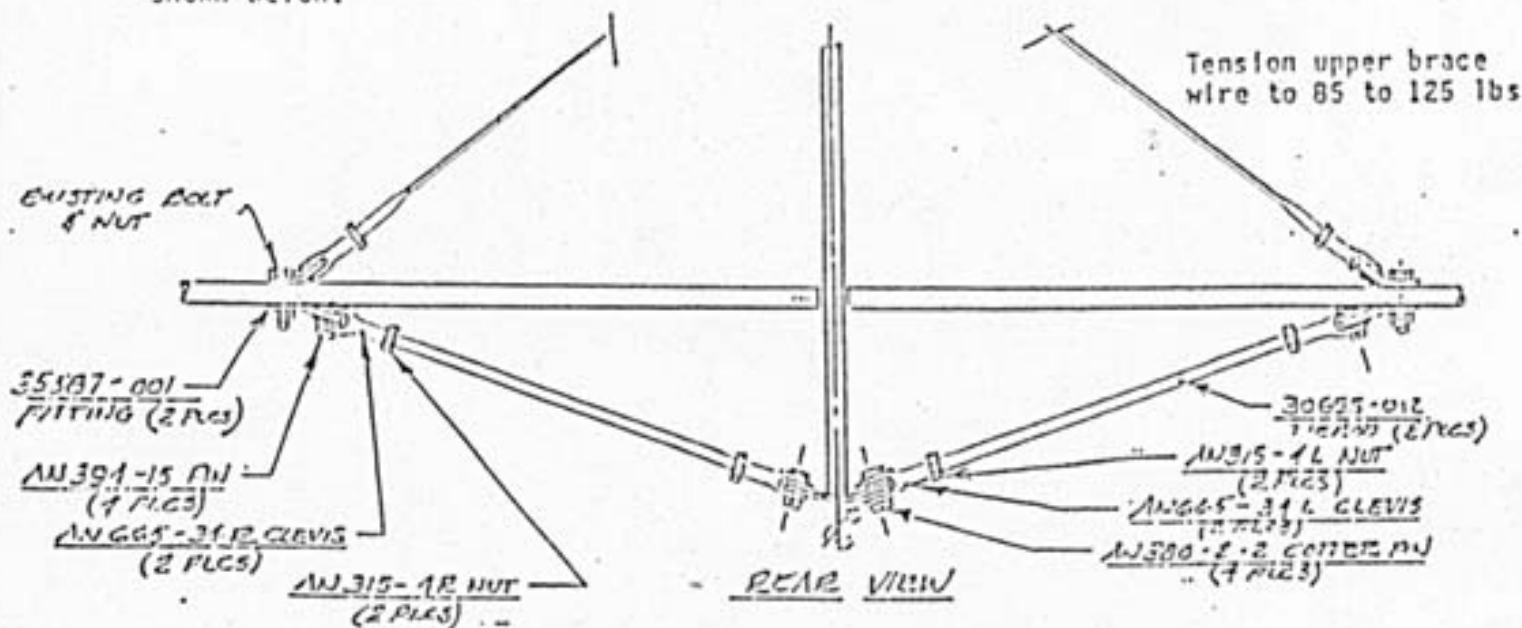
There have been several instances where the lower left rear tail brace strut has failed in the threaded stud welded in the inboard lower end of the strut.

In order to preclude the possibility of this type of failure in the future, please replace both rear lower struts with 1/4" dia. stainless steel tie rods as shown below:
