# Service Bulletin

Service Bulletin No. 2

SUBJECT: FRONT SEAT BACK REINFORCEMENT

MODELS AFFECTED: CHRISTEN A-1 HUSKY S/N's 1001 THRU 1125

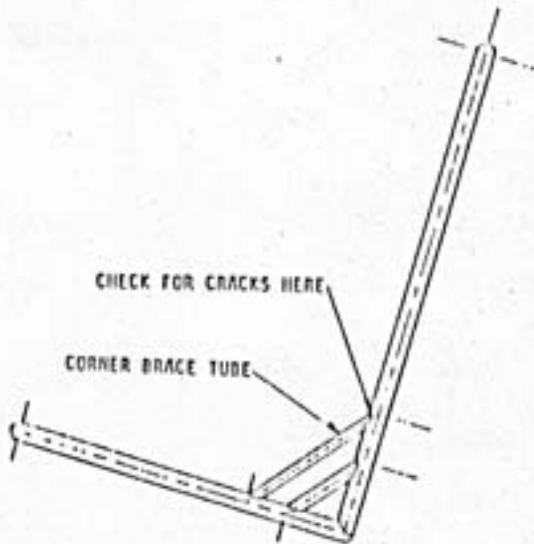
A front seat back on a Christen A-1 Husky airplane has failed at the point where the top corner brace welds to the seat back tube. Failure of the seat back could result in a serious accident. For this reason, an immediate mandatory inspection of the front seat back tubes is requested. If cracks are found at the junction of the corner brace tube and the seat back tube, the aircraft should be grounded immediately. If no cracks are found, the aircraft may continue to be flown but the inspection of the front seat back should be accomplished before each flight.

A bolt-on seat back brace, Christen P/N 35598-501 & 502, should be installed as soon as possible. The kit for this installation is available, free of charge, for all affected Husky aircraft.
