DATE: 12 November 2007

AIRCRAFT: Husky A-1B

SUBJECT: Flap Cable Link

MODELS AFFECTED: S/N 2397-2418

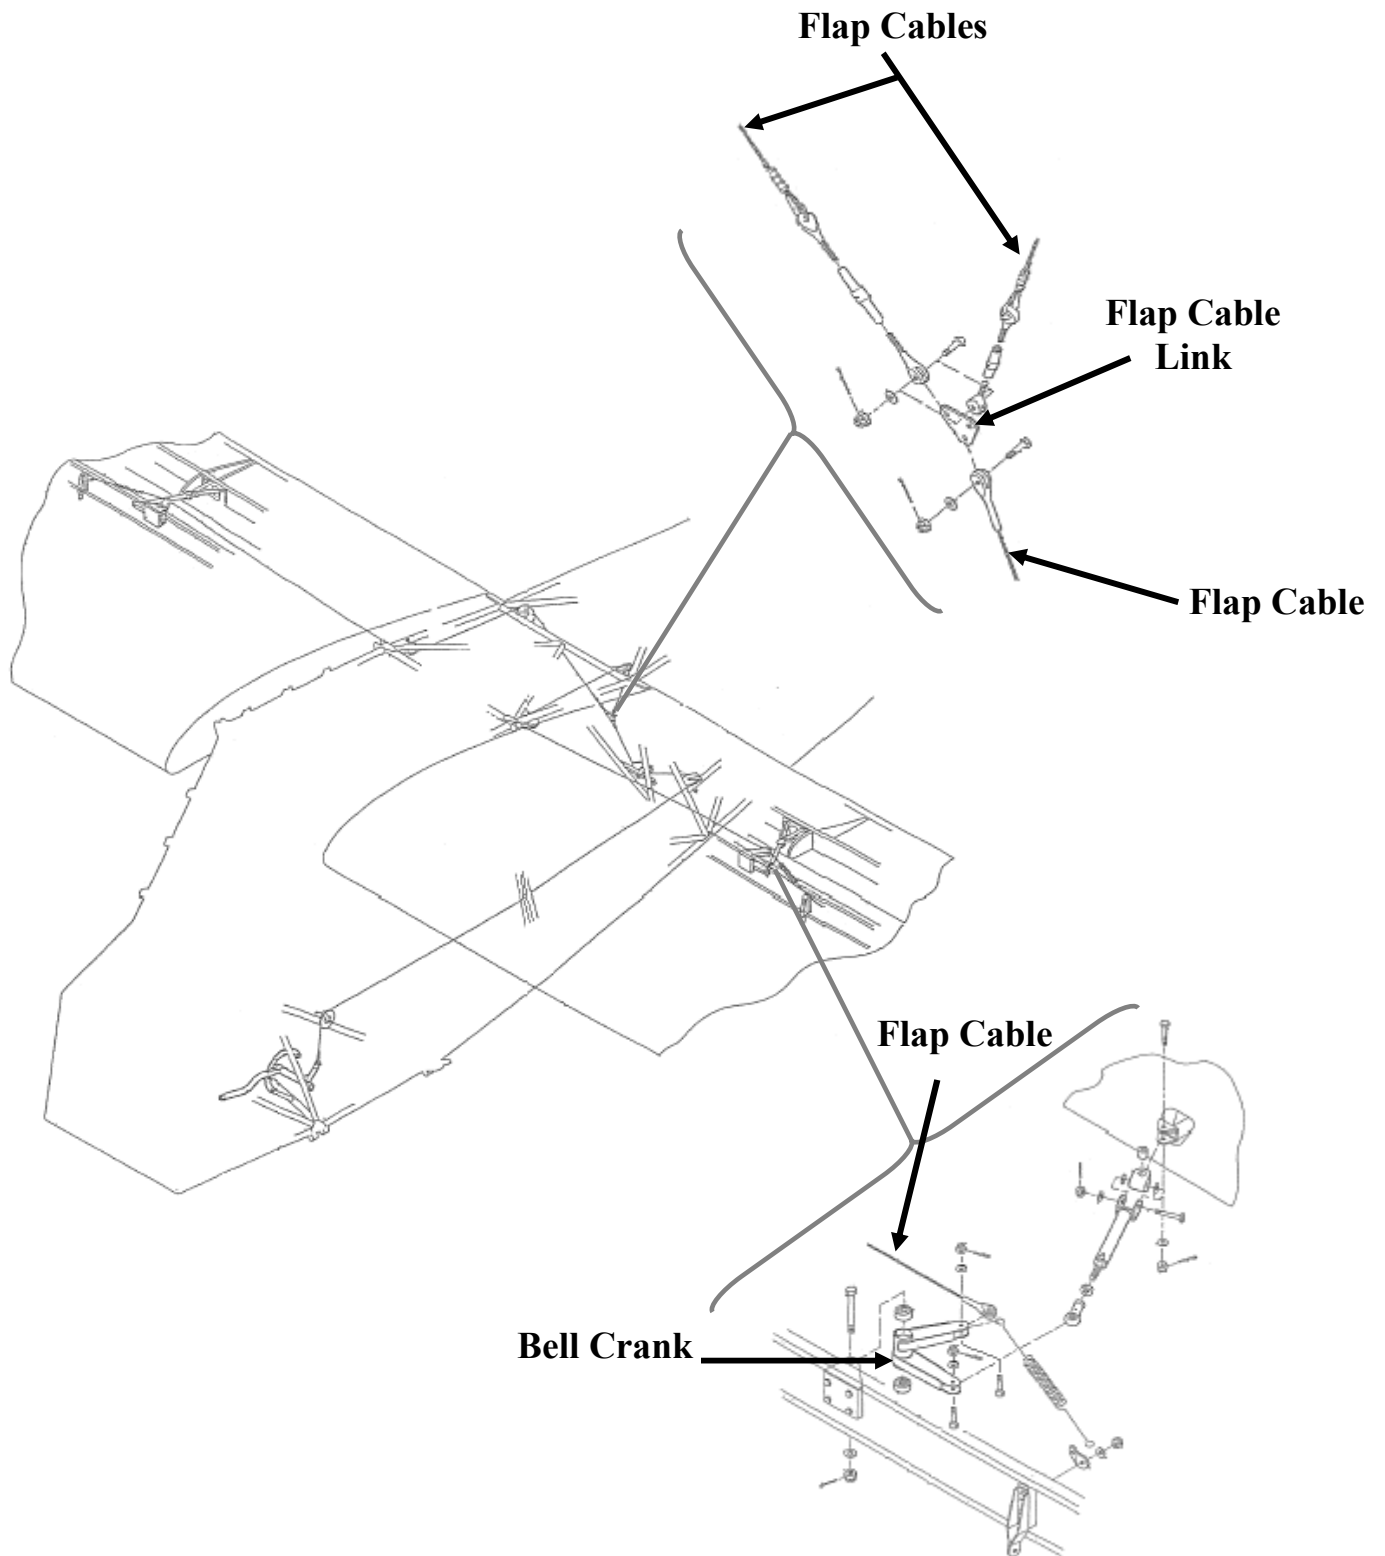
Figure 1 Flap System Diagram

During a routine inspection of a specific aircraft, it was found that the flap cable link (part number 35064-001) was fabricated from incorrect sheet stock. The link was made from 0.050" 4130N while the link should have been made from 0.100" 4130 N. This discrepancy affects Husky serial numbers 2397-2418.

Measure the flap cable link and determine if it is the appropriate thickness. See Figure 1. The part should have a base thickness (without paint) of 0.100 inches. Note that it is not necessary to remove the paint - the difference between a 0.100 inch part and a 0.050 inch part is great enough that the thickness of the paint does not affect the accuracy of the measurement.

If it is found that the flap cable link is one of the defective parts, a new link should be installed. The parts required to replace the link are available from Aviat Aircraft Inc. by requesting Kit# A-1B-521 and are as follows:

1. Undo the 5 cam locks and remove the left side access door and open the battery door.
2. Remove the bell crank access panels on the top of the wings (8 screws each, 1 on each wing).
3. On both sides of the airplane, disconnect the flap cable that attaches to the bell crank. This will release the tension in the cables.
4. Remove the cotter keys, bolts, nuts, and washers that attach the cables to the flap cable link (3 each) and remove the flap cable link.
5. Install a new flap cable link with new bolts, nuts, washers, and cotter keys (3 each).
6. Use 2 people to reconnect the flap cables. Have one person connect the cables to the bell cranks while the other person checks to make sure that the cables stay on the pulleys.
7. Close the battery door, attach the left side access door (5 cam locks), and attach both bell crank access doors on the tops of the wings (8 screws each).
