**SERVICE BULLETIN No.22 SKY INTERNATIONAL INC.**

**AIRCRAFT: All Husky A-1B and A-1C models equipped with 200HP fuel injected Lycoming engine.**

Bulletin No.: PRS-107

**SUBJECT:     HEX PLUG 383493 COMING LOOSE FROM REGULATOR COVER**

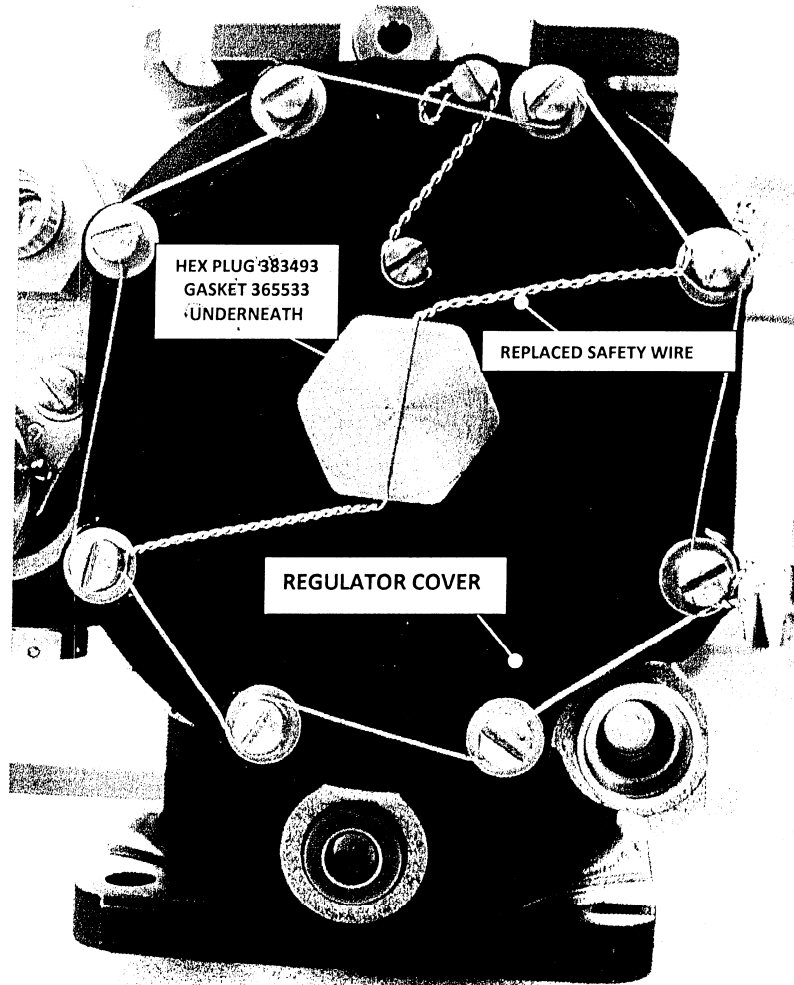
Note: Plug safety wire is wrapped around regulator screws under existing wire. It does not go through the holes in the screws.

6. With an acceptable hex plug, an acceptable regulator cover, and an acceptable gasket, install the gasket over the hex plug and install plug into the regulator cover. Torque the hex plug to 90-100 in-lbs.

7. The hex plug must be safety wired with .025 inch diameter wire to the regulator cover as shown in the figure below. The wire shall pass thru the plug such that it pulls the plug in the tightened direction and does not touch the corners of the hex on the plug.
