SERVICE BULLETIN No. 23 SKY INTERNATIONAL INC.

DATE: 27 March 2008

AIRCRAFT: Husky A-1B's equipped with Lycoming O-360A1P engines.

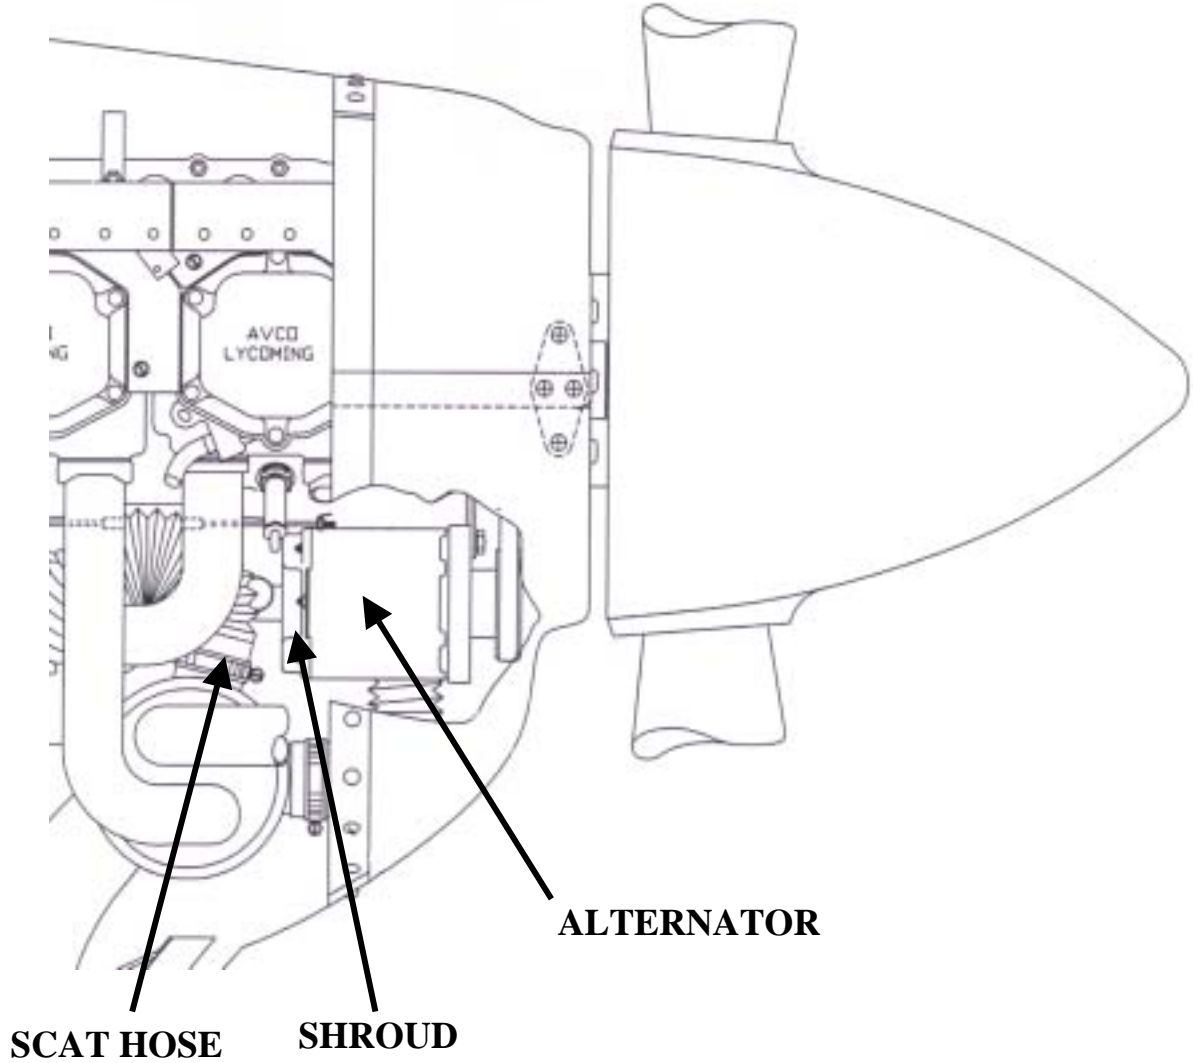
FIGURE 2

Some O-360 A-1P engines received from Lycoming were supplied with ALX8521LS, 70 amp alternators with a cooling shroud installed on the rear of the alternator. Since the aircraft has no provisions to connect the cooling shroud to an external air source, the cooling shroud must be removed in order for the alternator to dissipate heat properly.

- 1- Inspect aircraft and verify installed alternator model.
- 2- Aircraft equipped with ALX8521LS alternator with a cooling shroud installed on the rear of the alternator requires the cooling shroud be removed (See page 4, Figure 2 for cooling shroud location). To remove cooling shroud follow Accomplishment Instructions below.
- 3- Aircraft equipped with alternators ALX6521LS-1 or ALY8520LS requires completion and submittal of compliance letter only. (See Page 5).

- 1- Disconnect Battery.
- 2- Undo 4 camlocks on both cowl doors and lift up doors. (Figure 1)
- 3- Remove lower cowl. (Figure 1)
- 4- Loosen clamp on scat hose. (Figure 2)
- 5- Push scat hose with clamp attached out of the way. (Figure 2)
- 6- Shroud is attached to back of alternator with 4 screws. Remove 4 screws and shroud. It is not necessary to remove any wires. (Figure 2)
- 7- Reattach scat hose and tighten clamp.
- 8- Reinstall lower cowling.
- 9- Close doors and lock shut with camlocks.
- 10- Hook battery back up.
- 11- Document compliance to service bulletin in aircraft logbook and complete compliance letter instructions and submit.
