Service Bulletin

SERVICE BULLETIN NO. 3
ENGINEERING ASPECTS ARE FAA APPROVED

SUBJECT: Aircraft-Engine Vibration Levels

SUBJECT: Reindexing of Prop Flange Bushings

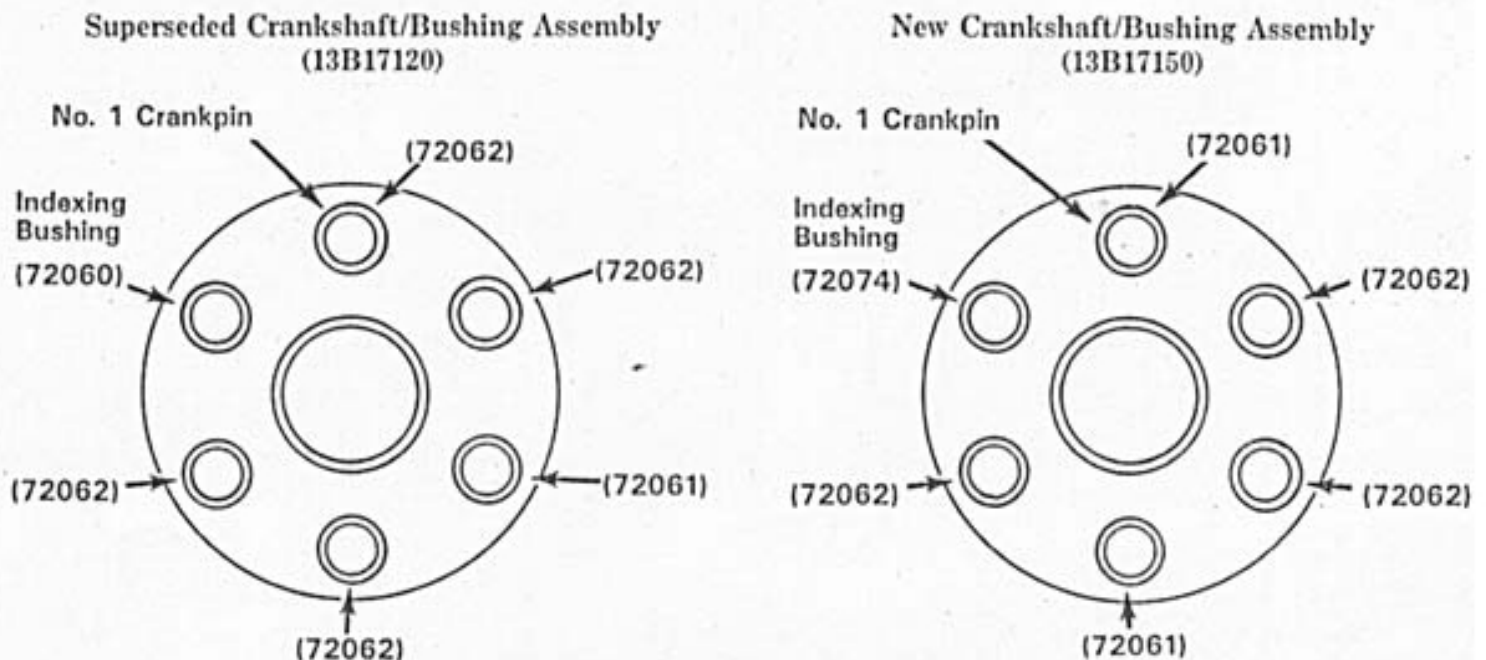
Figure 1. Bushing Indexing Configuration

For the purpose of improving cabin vibration characteristics in Christen Husky aircraft employing the subject engine model, prop flange bushings are reindexed as shown in Figure 1. Refer to latest edition of Service Instruction No. 1098 for installation of replacement bushings. (Service-replacement bushings are designated with the suffix "S".)

Upon compliance with this Service Instruction, re-identify the new bushing configuration by vibropeening the new crankshaft/bushing assembly part number on the outside diameter of the prop flange. Note in log book.
