Service Bulletin

SERVICE BULLETIN NO. 7
ENGINEERING ASPECTS ARE FAA APPROVED

SUBJECT: Ignition/Starter Switch on Christen A-1 Husky

MODELS AFFECTED: Christen A-1 Husky Aircraft, S/N's 1001 thru 1158

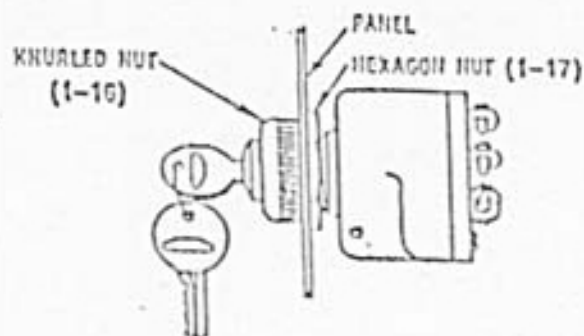
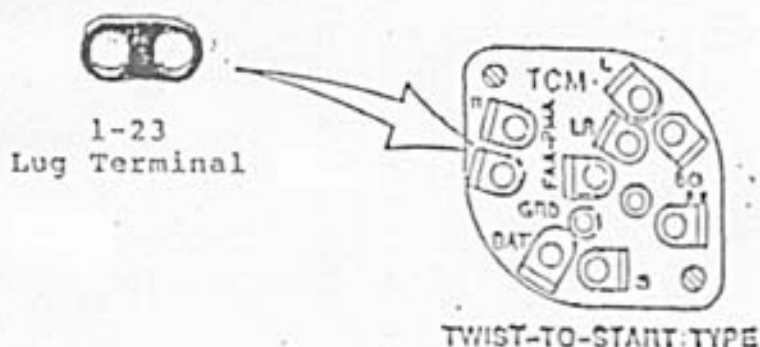
It has recently come to our attention that some Husky aircraft are equipped with Bendix ignition switches that do not incorporate a lug terminal (P/N 1-23) across the terminals nearest the "R" mark

The result is that the right magneto is not grounded during engine starting and the spark is, therefore, not retarded during the engine starting procedure.

If the 1-23 lug is not installed, please contact Christen Industries Inc., Afton, Wyoming, for a 1-23 lug which should be installed across the "R" terminals as shown in the illustration below.
