CHRISTEN INDUSTRIES, INC.
1048 SANTA ANA VALLEY ROAD
HOLLISTER, CALIFORNIA 95023
TELEPHONE: (408) 637-7405

Applies: 906 TAIL STRUCTURES KIT

C-0002

Subject: INSPECTION OF ELEVATOR
HORN FOR CRACK AT TOP
EDGE OF FLANGE

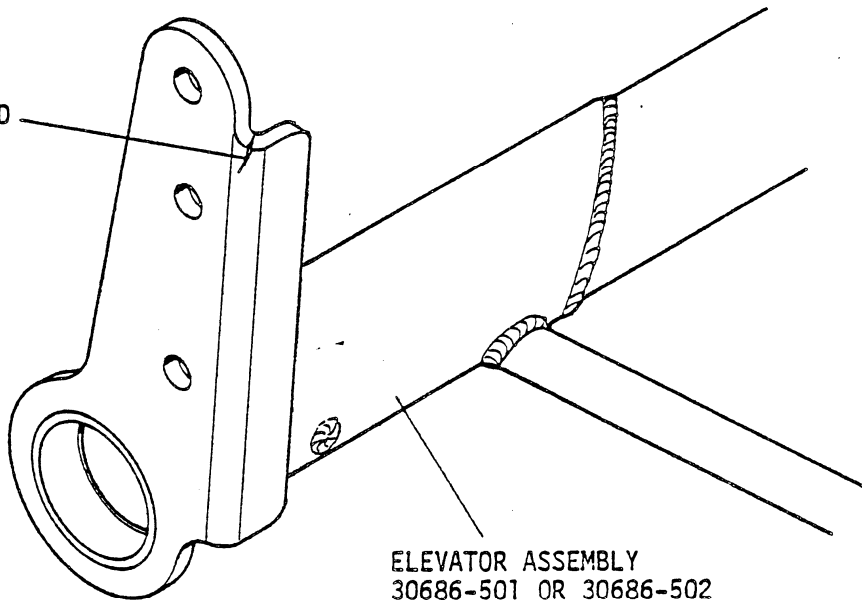
ELEVATOR ASSEMBLY
30686-501 OR 30686-502

There is a possibility that a small crack may exist on the horn of your 30686-501 or 30686-502 elevator assembly. The enclosed Engineering Sketch X-90011 illustrates the location of the possible crack.

INSPECT FOR POSSIBLE
CRACK AT EDGE OF BEND
RADIUS

Please inspect the horns on your elevator assemblies carefully for the presence of cracks. Remove the black paint if necessary to allow careful observation of the bare metal surface. Be sure to prime and repaint the area as appropriate after completing the inspection.

If an elevator horn is cracked, it may be repaired by filling the crack by welding and then filing the surfaces smooth. If preferred, the elevator assembly may be returned to the Christen factory for warranty replacement or rework.
