No: 000268

Subject: CRACKS IN EXHAUST
MANIFOLD ASSEMBLIES OF
EAGLE II AIRCRAFT

ENCLOSURE: Engineering Sketch X-90139

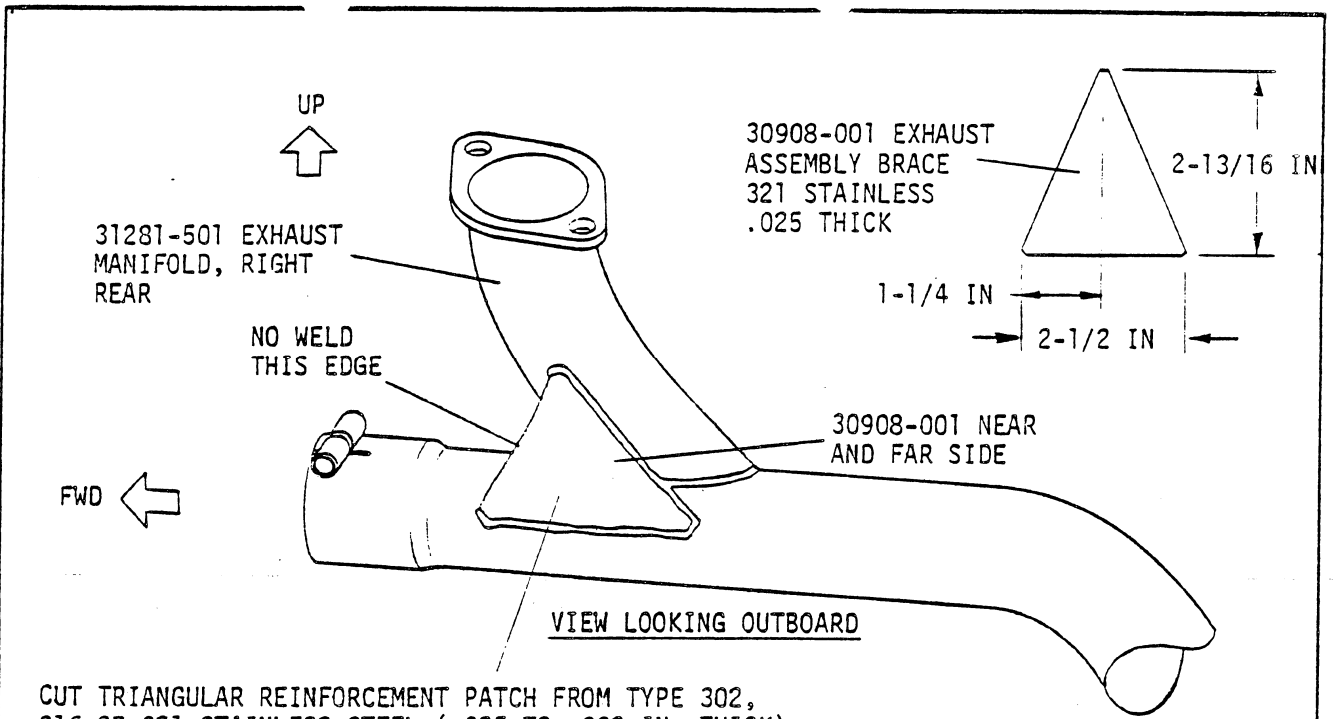
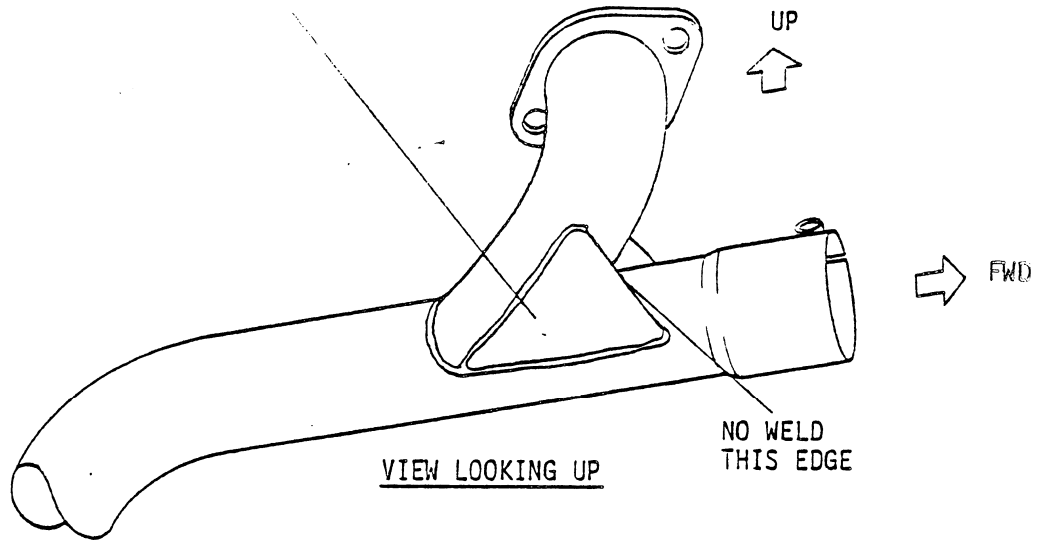
Eagle builders indicate that even when the exhaust manifolds are installed and tightened properly cracking may occur. Some aircraft have been operated for as long as 400 hours with no evidence of cracking; however, other aircraft have developed cracks during the first 25 hours of aircraft operation. When the cracking does occur, it is always located near the rear Y-joint of the aft manifold assembly, and it is most prevalent on the right rear manifold assembly. Analysis and testing have not explained the difference in cracking tendency among the various aircraft.

The manifold modification shown on the attached Engineering Sketch X-90139 eliminates the cracking problem, and all future Eagle II exhaust manifold assemblies will be supplied with the gusset-style brace shown on the sketch. We recommend that all Eagle II builders modify their exhaust manifolds in a similar way. Parts or factory service is available as follows:

CUT TRIANGULAR REINFORCEMENT PATCH FROM TYPE 302, 316 OR 321 STAINLESS STEEL (.025 TO .032 IN. THICK) OR USE CHRISTEN PART 30908-501. T.I.G. TACK WELD AND HEAT TO FORM EDGES INTO CLOSE CONTACT WITH MANIFOLD BEFORE COMPLETING T.I.G. WELDING. 2 PLACES.
