No: 000272

Send To: 912 NAVCOM KIT

Subject: RETENTION OF EDO-AIRE  
RADIOS IN EAGLE II  
AIRCRAFT

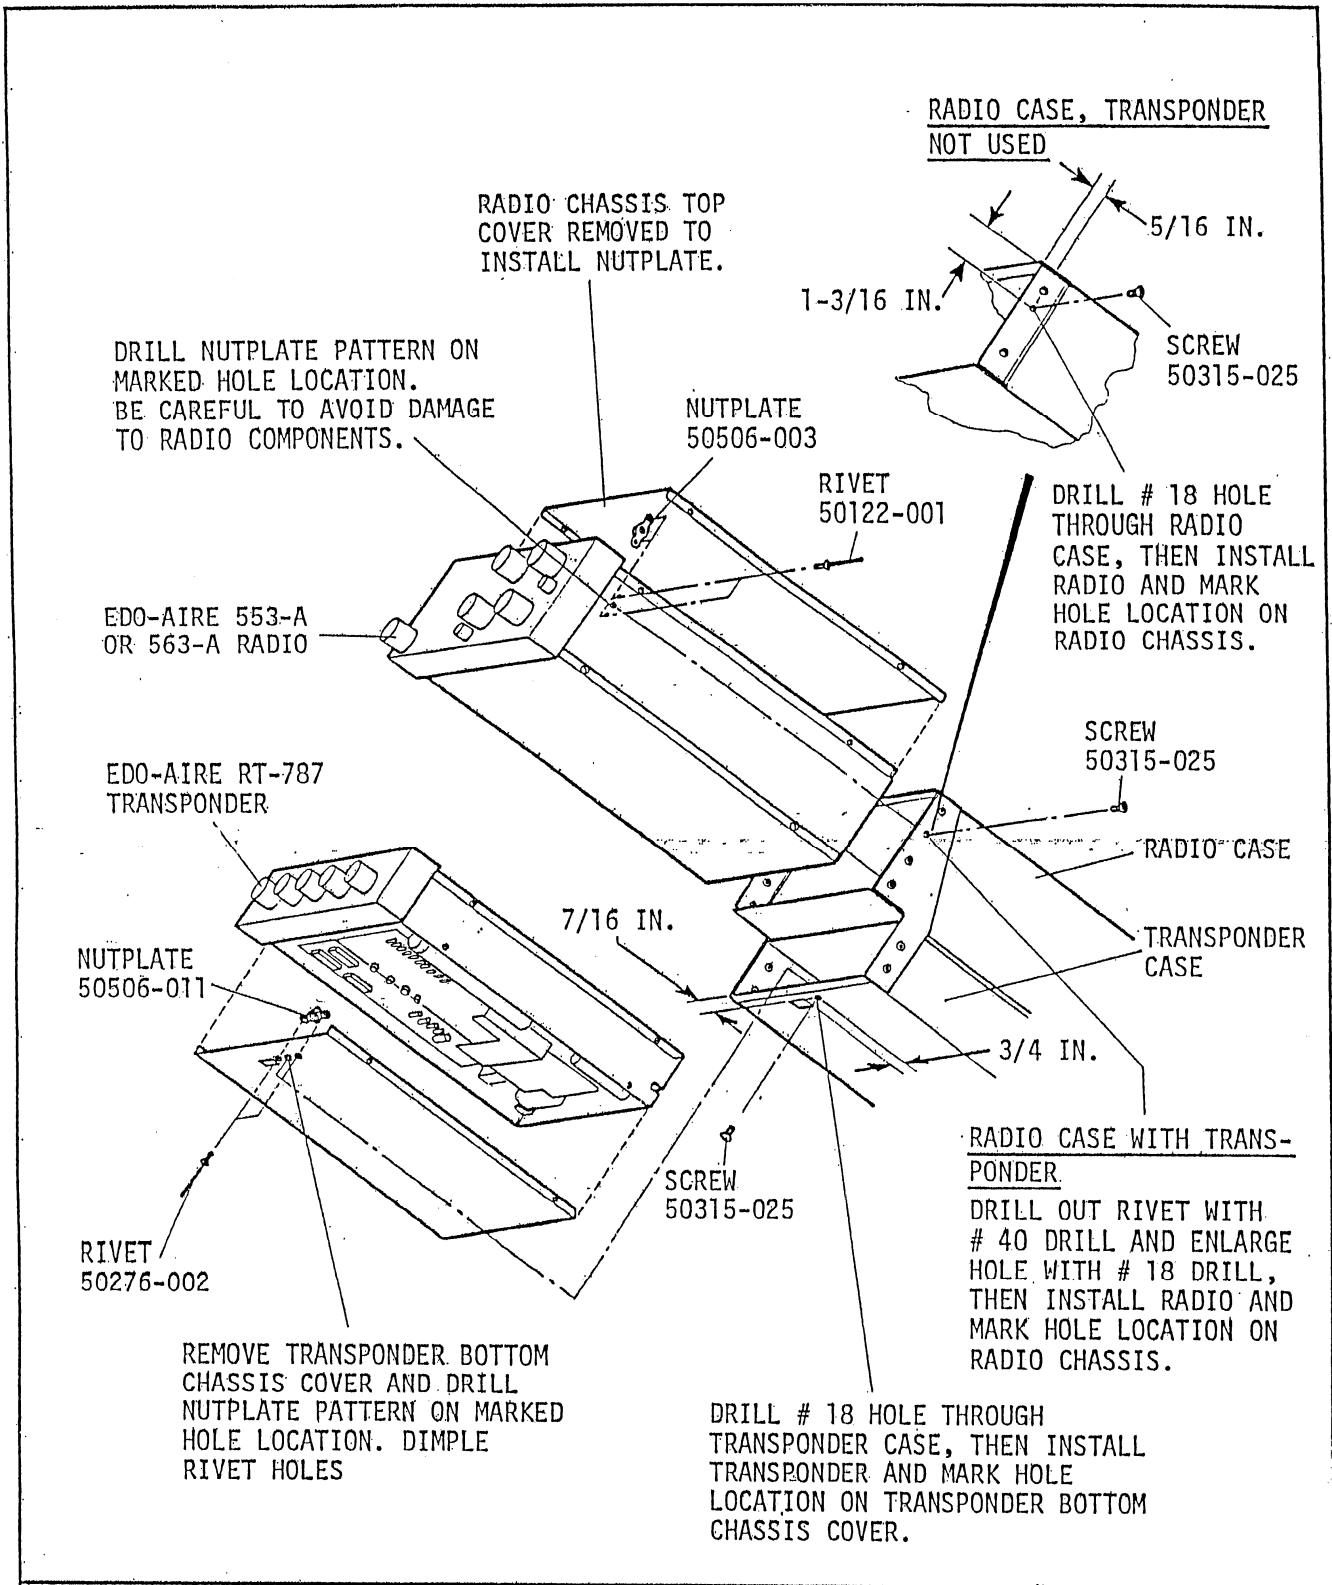
An Eagle builder whose aircraft has the current hook-tab retaining system reported recently that during performance of inverted flight with moderately high negative G-loads his radio came out of the housing with sufficient momentum to injure his hand and to completely penetrate the canopy bubble. The builder is confident that the radio retaining tab was engaged properly and that the tab must have failed, but the radio was lost so this cannot be verified. Failure of the tab is inconsistent with factory testing and aerobatic flight experience.

Although we cannot confirm any inadequacy in the current radio retention system, we want to ensure that there is no possibility of a radio coming free from its support housing during flight, regardless of builder attentiveness in engaging the radio retention system. Therefore, we have added a screw and nutplate retaining system to both the 912 Navcom Kit and the 912-T Transponder Kit. In this system a nutplate is mounted on the inside surface of the radio chassis and a screw extends through the sidewall of the radio support housing to engage the nutplate. The arrangement and installation instructions are shown on the enclosed copy of Engineering Sketch X-90151. The parts for this retention system will be included in all future 912 Kits, and parts are enclosed for retrofit to aircraft whose 912 Kits have already been delivered.

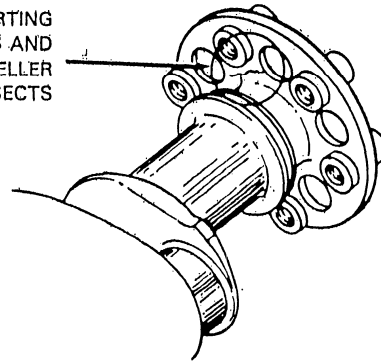
Figure 1. Rear View of Propeller Mounting Flange Showing Area of Lightening Holes.

LOOK CLOSELY FOR CRACKS STARTING BETWEEN THE LIGHTENING HOLES AND ON THE BACK OF THE PROPELLER FLANGE WHERE THE FILLET INTERSECTS THE FLANGE AND CRANKSHAFT.

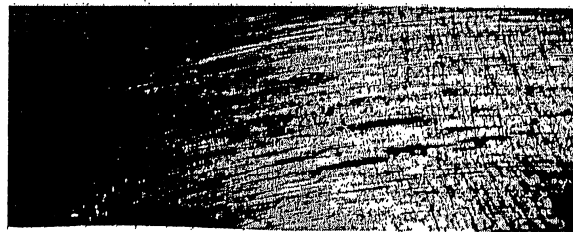
Figure 2. 10X Magnified View Showing Appearance of Area Cracked Due to Abnormal Loading Imposed on the Propeller Flange During Periods of Aerobatic Maneuvers.

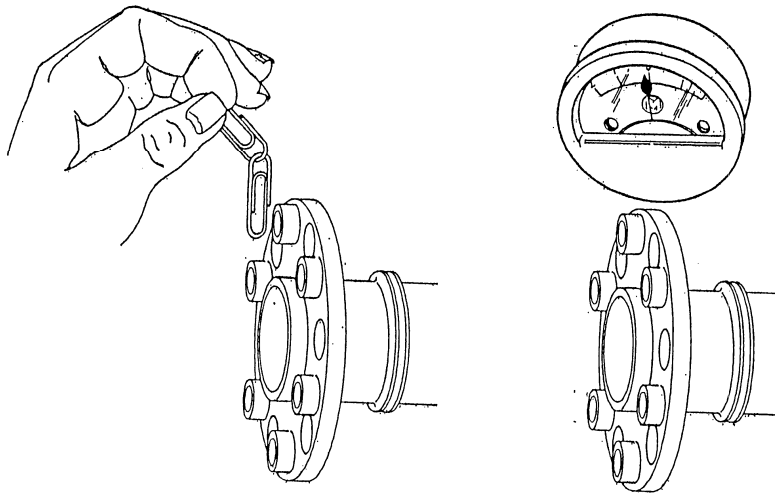
A rotating, magnetized propeller flange could set up a magnetic field strong enough to magnetize check valves in the hydraulic lifters and to interfere with flux fields in the magnetos and avionics.

Figure 3. Residual Magnetism in the Propeller Flange can be Detected with a Field Indicator or a Suspended Steel Paper Clip.
