No: 000317

CHRISTEN INDUSTRIES, INC.  
1048 SANTA ANA VALLEY ROAD  
HOLLISTER, CALIFORNIA 95023  
TELEPHONE: (408) 637-7405

Subject: INSPECTION OF LANDING  
GEAR SUPPORT STRUCTURE  
ON FUSELAGE OF EAGLE II  
AIRCRAFT

ENCLOSURES: ENGINEERING SKETCH X-90165

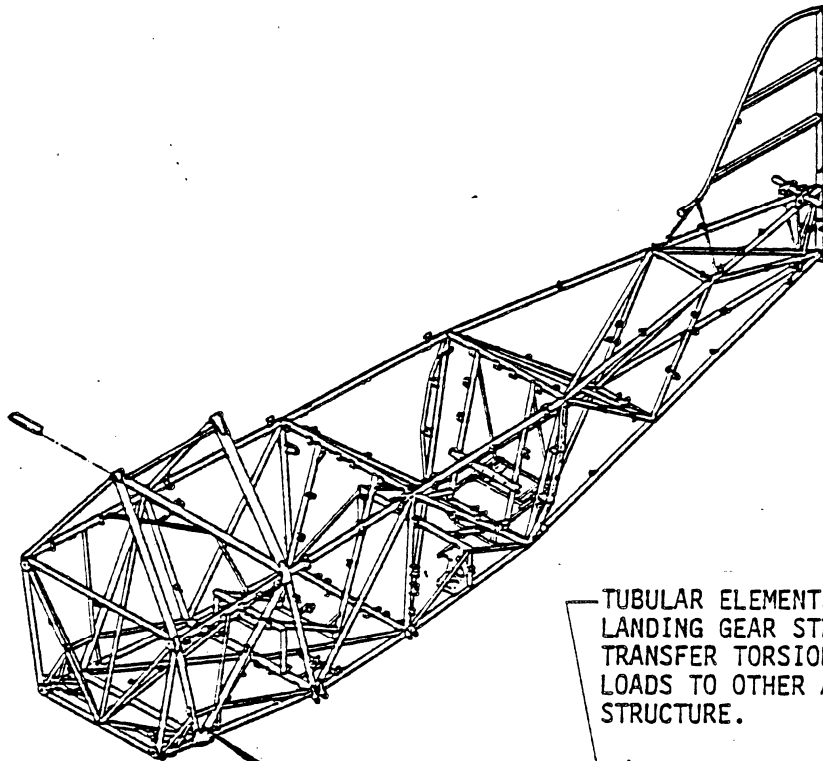
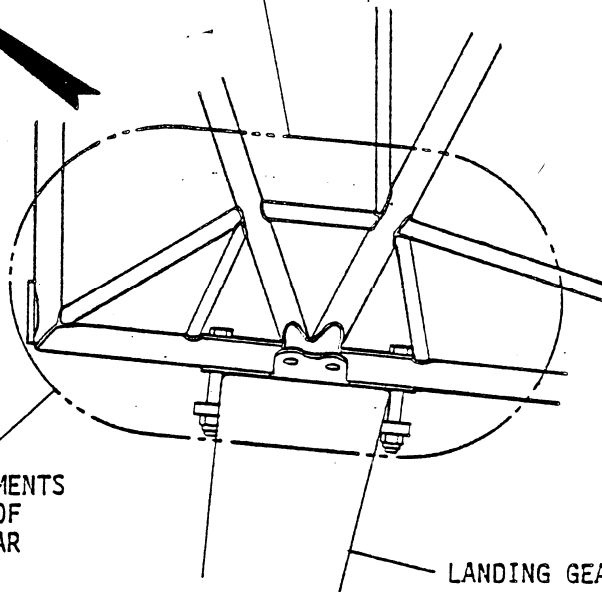
TUBULAR ELEMENTS WHICH SUPPORT LANDING GEAR STRUT AND WHICH TRANSFER TORSIONAL AND BENDING LOADS TO OTHER AREAS OF FUSELAGE STRUCTURE.

INSPECT FOR CRACKS ON ALL SURFACES OF ALL TUBULAR ELEMENTS IN THIS AREA ON BOTH SIDES OF FUSELAGE AS A PART OF REGULAR INSPECTIONS.
