CHRISTEN INDUSTRIES, INC.
1048 SANTA ANA VALLEY ROAD
HOLLISTER, CALIFORNIA 95023
TELEPHONE: (408) 637-7405

C * MULTIPLE LETTER MAILING * Subject: INSTALLATION OF ANTI-
U CHAFE AND ANTI-VIBRATION
S SEE FIRST LETTER FOR TAPE ON PROPELLER HUB
T NAME AND ADDRESS. OF EAGLE II AIRCRAFT

ENCLOSED: ENGINEERING SKETCH X-90167

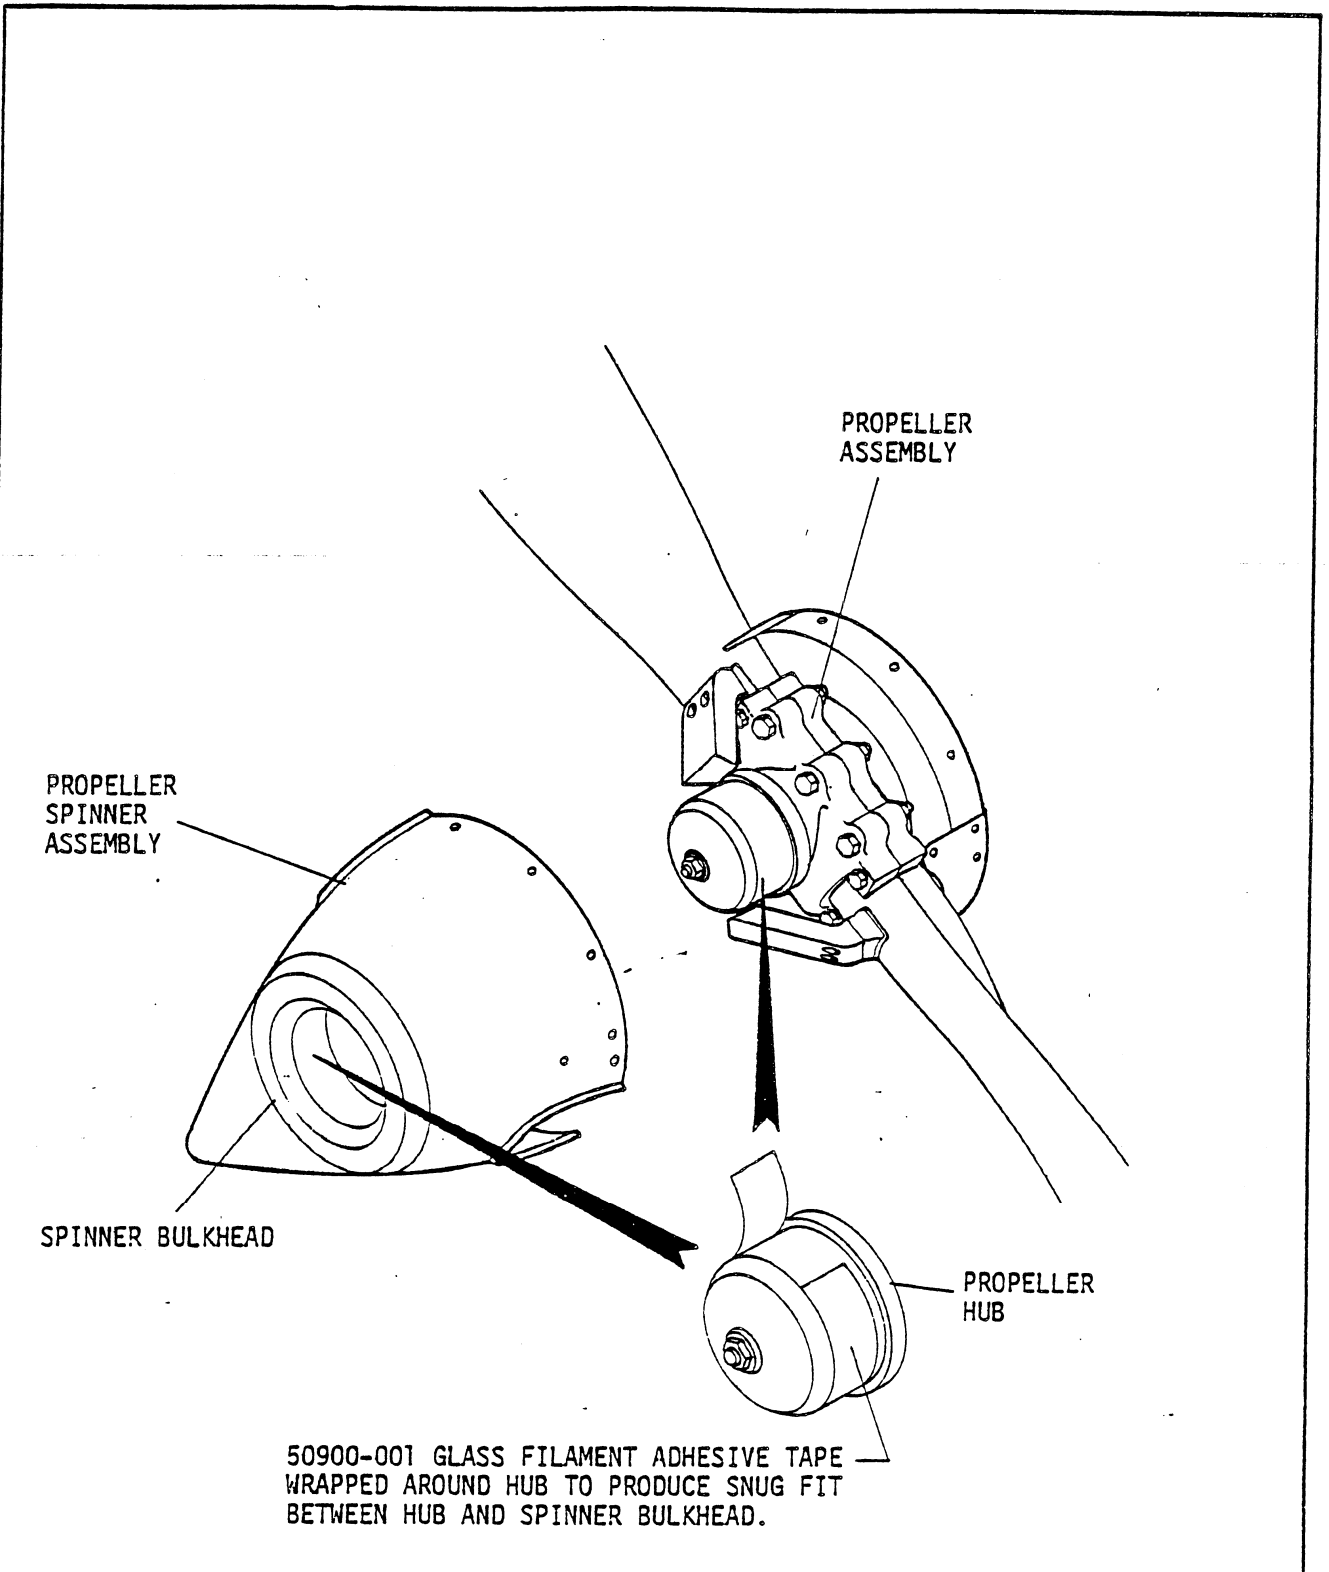
Several Eagle II builders have discovered cracks in the spinner bulkheads when performing periodic inspections. Investigation of the cracking problem has revealed that radial play between the forward propeller bulkhead and the propeller hub allows sufficient movement of the spinner assembly to cause fatigue and eventual cracking of the bulkheads or shell.

All Eagle II builders should immediately inspect the spinner shell and bulkheads for cracks and should install the enclosed tape on the hub of the propeller as shown in the enclosed sketch. The tape will be a standard part of 919 Propeller Kits delivered in the future.

50900-001 GLASS FILAMENT ADHESIVE TAPE WRAPPED AROUND HUB TO PRODUCE SNUG FIT BETWEEN HUB AND SPINNER BULKHEAD.
