PRODUCT LETTER

No: 000331

Subject: PROPELLER FLANGE FAILURES  
ON LYCOMING ENGINES AND  
LYCOMING SERVICE BULLETIN  
465 ISSUED ON 08-26-83.

Service Bulletin No. 465C  
(Supersedes Service Bulletin No. 465B)  
Engineering Aspects are  
FAA Approved

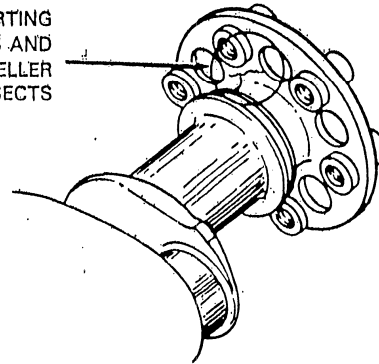
Figure 1. Rear View of Propeller Mounting Flange  
Showing Area of Lightening Holes.

quate light. Inspect the entire flange area from the crankcase oil seal forward. Pay particular attention to the rear face and fillet radius of the propeller flange. See Figure 1. Figure 2 shows an area of the propeller flange with cracks developing.

LOOK CLOSELY FOR CRACKS STARTING  
BETWEEN THE LIGHTENING HOLES AND  
ON THE BACK OF THE PROPELLER  
FLANGE WHERE THE FILLET INTERSECTS  
THE FLANGE AND CRANKSHAFT.

1. After every 25 hours of operation, the propeller and starter ring gear support must be removed and the propeller mounting flange must be visually inspected. Use a 10X power magnifying lens with ade-

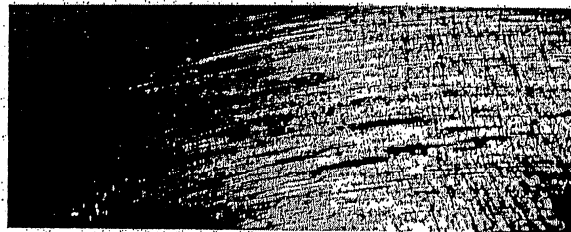
Figure 2. 10X Magnified View Showing Appearance of Area Cracked Due to  
Abnormal Loading Imposed on the Propeller Flange During Periods of  
Aerobatic Maneuvers.

It has been determined that excessive stress from aerobatic maneuvers can cause cracking and the eventual failure of the crankshaft propeller mounting flange. To reduce the risk of propeller flange failure, Avco Lycoming has re-designed the propeller mounting flange on crankshafts assembled in engines built for installation in aerobatic aircraft. These new crankshafts incorporate a thicker flange. In addition, the lightening holes are omitted, where applicable. Operators of Lycoming powered aircraft involved in aerobatic maneuvers are urged to install this new crankshaft at the earliest convenience.

2. After 200 hours of operation and at 100 hour intervals thereafter, the propeller mounting flange must also be examined with portable magnetic particle inspection equipment. A record of each visual and magnetic particle inspection should be entered in the engine logbook.

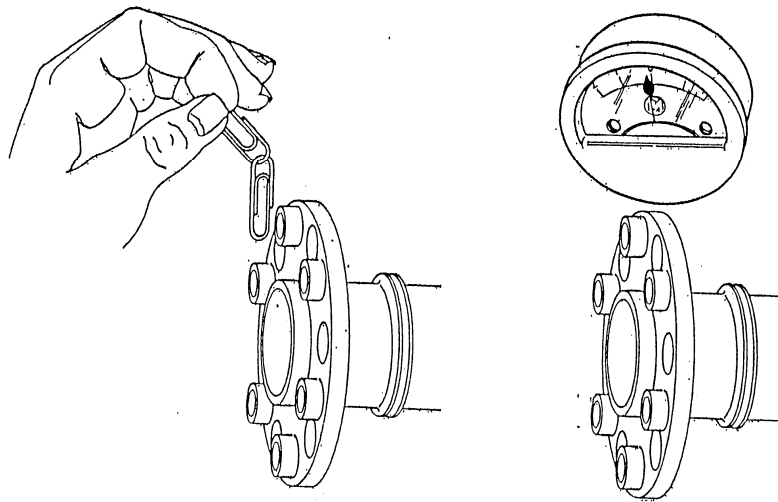
Figure 3. Residual Magnetism in the Propeller Flange can be Detected with a Field Indicator or a Suspended Steel Paper Clip.

A rotating, magnetized propeller flange could set up a magnetic field strong enough to magnetize check valves in the hydraulic lifters and to interfere with flux fields in the magnetos and avionics.

To detect residual magnetism in the flange, perform the following test as shown in Figure 3. Hold a field indicator approximately 1/8-inch from the flange. If needle moves more than one (1) indication from zero (0), repeat the demagnetization procedure in step 8.

An alternate method for detecting residual magnetism in the propeller flange is to suspend a steel paper clip approximately 1/8-inch from the flange, per Figure 3. Any appreciable magnetism will attract the paper clip.
