AVIAT AIRCRAFT INC.

SERVICE BULLETIN

SERVICE BULLETIN NO.24

SUBJECT: Fuselage Upper Longerons

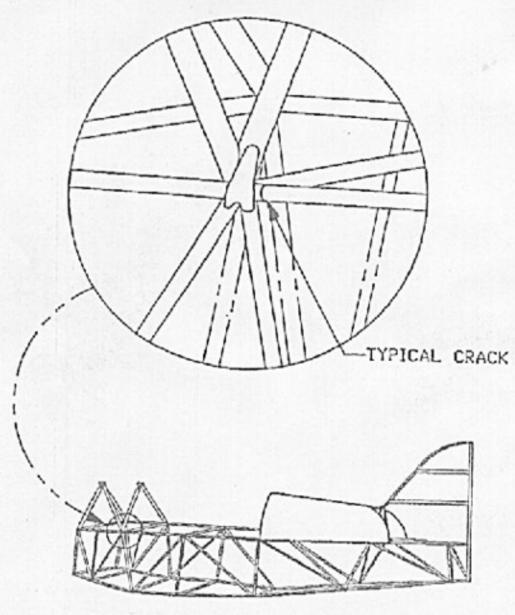
Figure 1

There have been a few instances, with the Model S-2B, of fatigue cracking of the upper longerons just aft of the rear cabane struts and forward of the front instrument panel. Continued operation following the failure of one longeron is characterized by airframe noises and the possible early failure of the other longeron with subsequent difficulty in controlling the airplane.

- 3.) Thoroughly inspect the upper longerons on both sides of the fuselage for cracks in the region just aft of the weld attaching the rear cabane strut to the longeron, using a 10X magnifying glass. Typical crack locations on both left and right longerons are shown in Figure 1.

TYPICAL LUCATION OF CRACK

- If no cracks are found, reassemble the aircraft and make a suitable log book entry.
- If cracks are found, ground the aircraft immediately and contact Aviat Aircraft Inc. for repair instructions.
