PITTS AVIATION ENTERPRISES, Inc.

SERVICE LETTER NO. 2

Subject: Reinforcement of flapper door of alternate air heat box assembly. P/N 2-7112-12.

Subject: Inspection of upper wing front spar to cabane fitting, P/N 1-410-12.

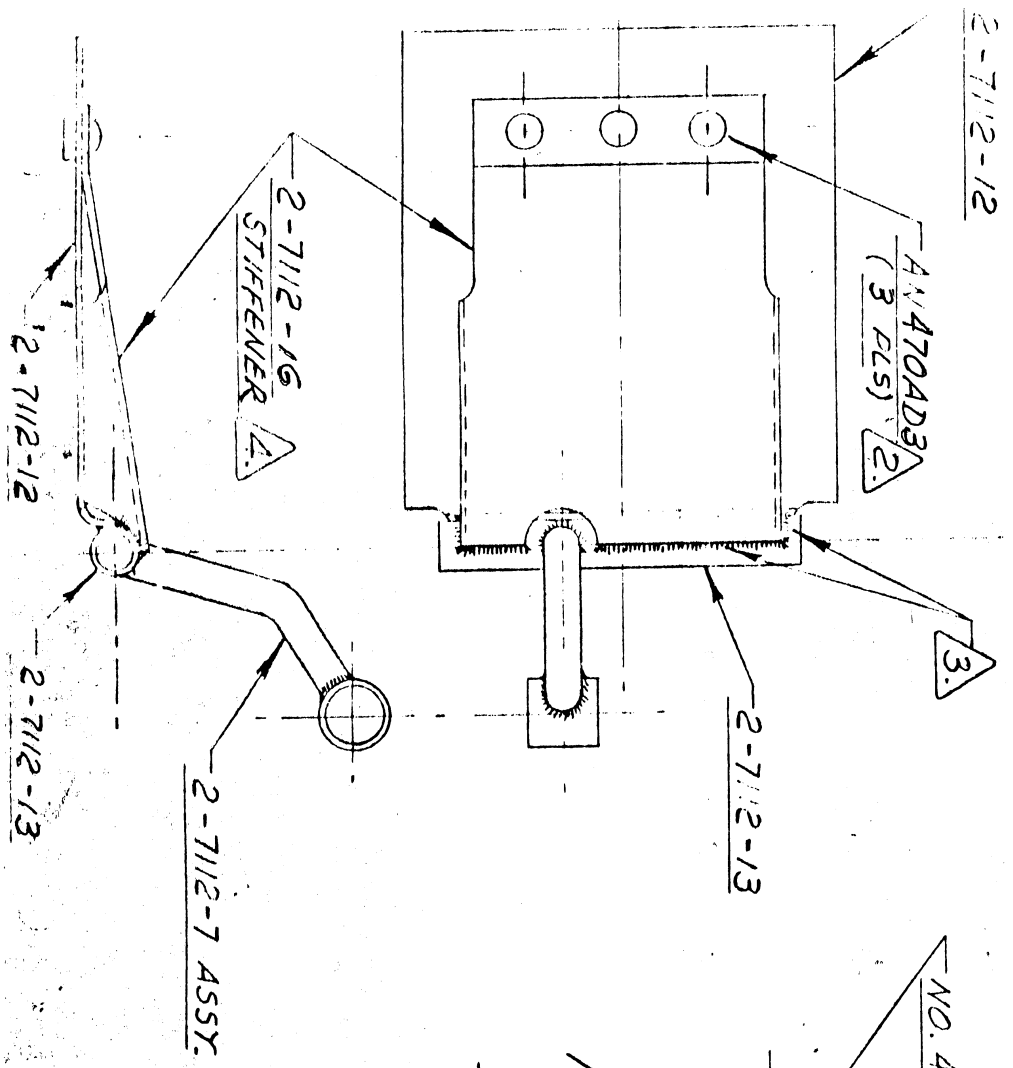
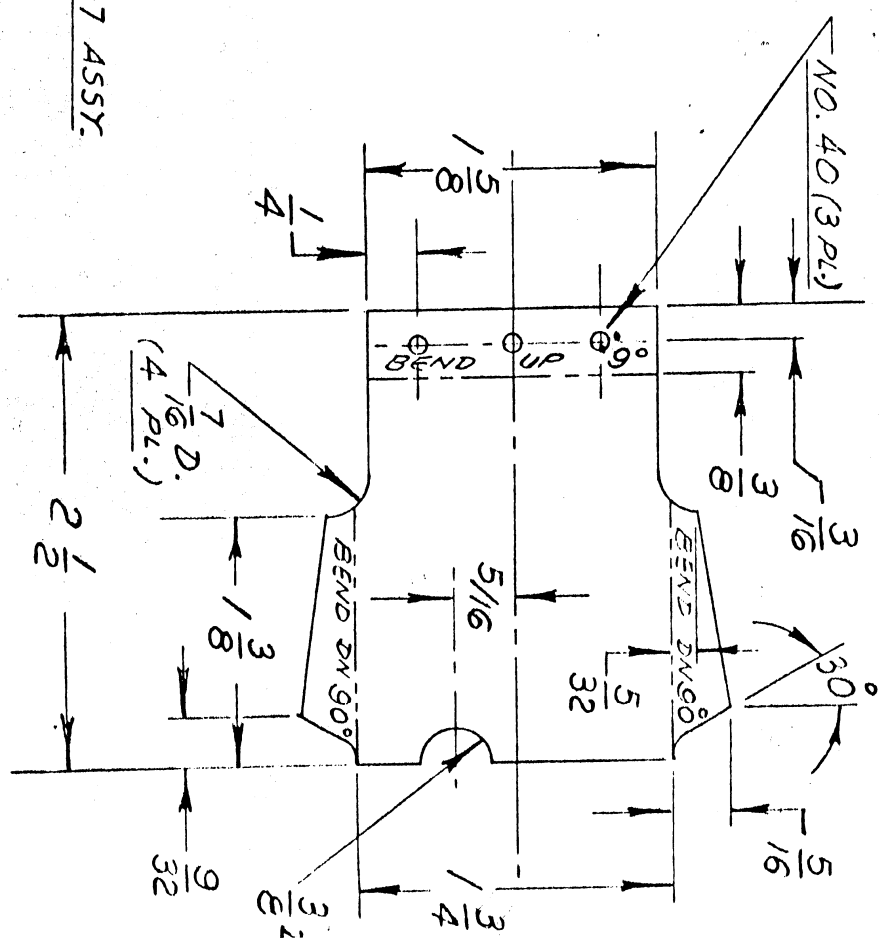
2-7112-16 STIFFENER
 FLAT PATTERN FULL SIZE

We do not believe at this time that the likelihood of failure of this unreinforced element is sufficiently high that a mandatory Service Bulletin is justified; however, we do suggest that your present flapper door be checked to see if cracks exist next to the hinge line. If so, the cracks should be welded shut and the 2-7112-16 stiffener added, as shown on sheet 2. of 2. (on reverse side).

1. REF. DWG. NO. 2-7112, NC, 3-18-71. THE ONLY ADDITIONAL PARTS REQ'D ARE:
 2-7112-16 (1 REQ'D) AND AN470AD3 (3 REQ'D).
2. ALIGN 2-7112-16 AS SHOWN & DRILL (3) NO. 40 HOLES IN 2-7112-12, USING HOLES IN -16 AS GUIDE. INSTALL (3) AN470AD3 RIVETS AS SHOWN.
3. WELD -16 TO -13 AS SHOWN ONLY ALONG INDICATED EDGE, AND ON ADJACENT EDGES GOVT DOWN TO CENTERLINE OF -15. DO NOT WELD -16 TO -12. MAKE FROM 430W STEEL PER MIL-S-18729, .025 X 2 1/2 X 2 3/8. MIN. BEND RADIUS 1/16. TWO 90° BENDS TO BE ACROSS GRAIN OF -16.
- 4.
