DATE: April 02, 2015

SUBJECT: Stabilizer Support Tube Inspection and Repair

REVISION: A

**HUSKY MODELS: A-1, A-1A, S/N 1468 & BELOW
A-1B, S/N 2397 & BELOW
A-1B-WF, S/N 0002 & BELOW
A-1B-NF, S/N 0008 & BELOW
A-1C, S/N 3198 & BELOW**

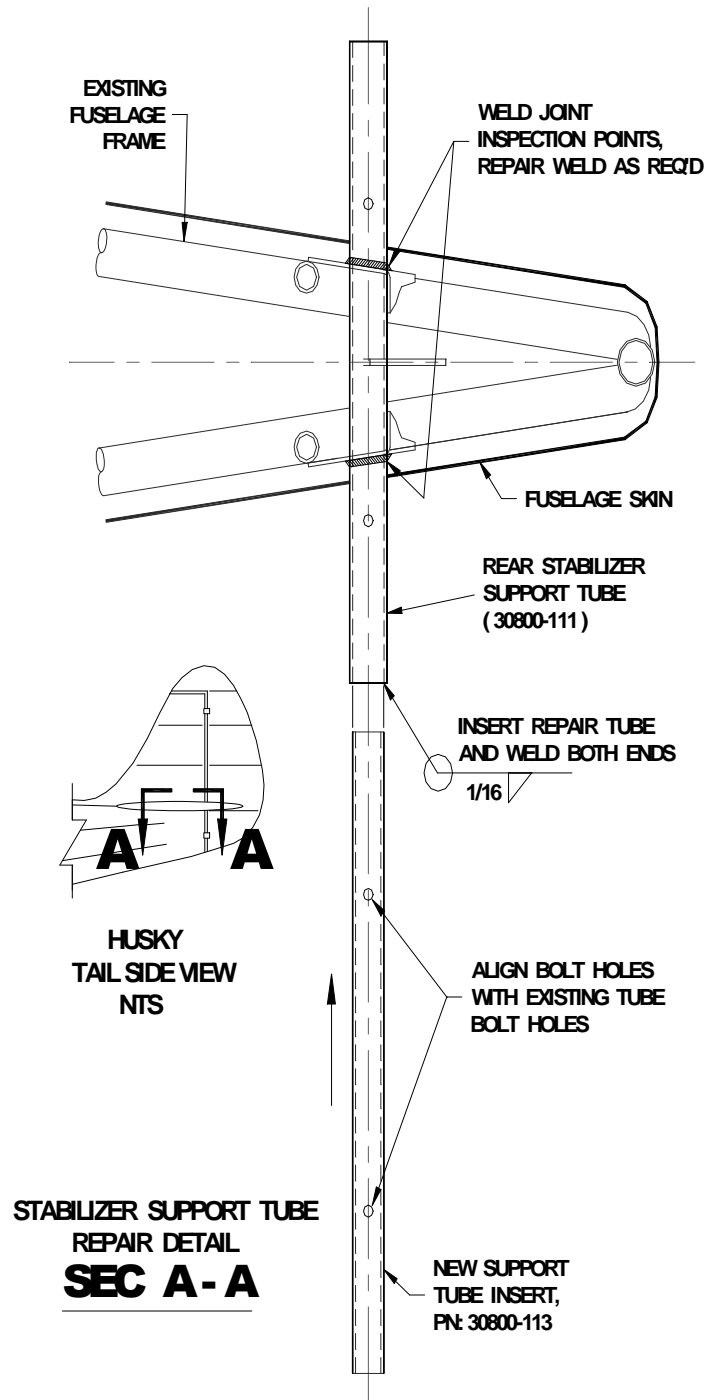
1. Mandatory Inspection:
 - a. Begin by removing inspection access covers located above and below rear support tube.
 - b. Visually inspect entire circumference of support tube at weld joint between fuselage frame and fabric for corrosion or damage.
 - c. If damage is verified or suspected, proceed to Recommended Repair instructions.

- c. If you suspect damage to weld joints, perform a resonance test by tapping on support tube and listening for "dead" sounding resonance.
 - d. If mechanic is unable to effectively determine damage, it may be decided that fuselage fabric must be opened to enable access for a more thorough investigation or to perform a weld joint repair. If damage is detected, proceed to (e). If no damage is detected, proceed to (f/g).

- e. Insert repair tube inside existing stabilizer support tube, align bolt holes, and weld both ends using AWS ER70S-2 welding rod in accordance with AC 43.13-1B, Chapter 5.

- g. Reinstall stabilizers, elevators and controls.
 - h. It is recommended to replace all stabilizer mounting bolts & nuts. Any questions on rigging, refer to Instructions for Continued Airworthiness Doc: Model A-1, A-1A; see 70192-002 section 1, 3.10, Model A-1B; see 70192-004 section 1, 3.10, Model A-1C; see 70192-006 section III, 5.2d.
