SUBJECT: Stabilizer Support Tube Inspection and Repair

HUSKY MODELS: A-1, A-1A, S/N 1468 & BELOW
A-1B, S/N 2397 & BELOW
A-1B-WF, S/N 0002 & BELOW
A-1B-NF, S/N 0008 & BELOW
A-1C, S/N 3198 & BELOW

SERVICE BULLETIN #28 COMPLIANCE LETTER

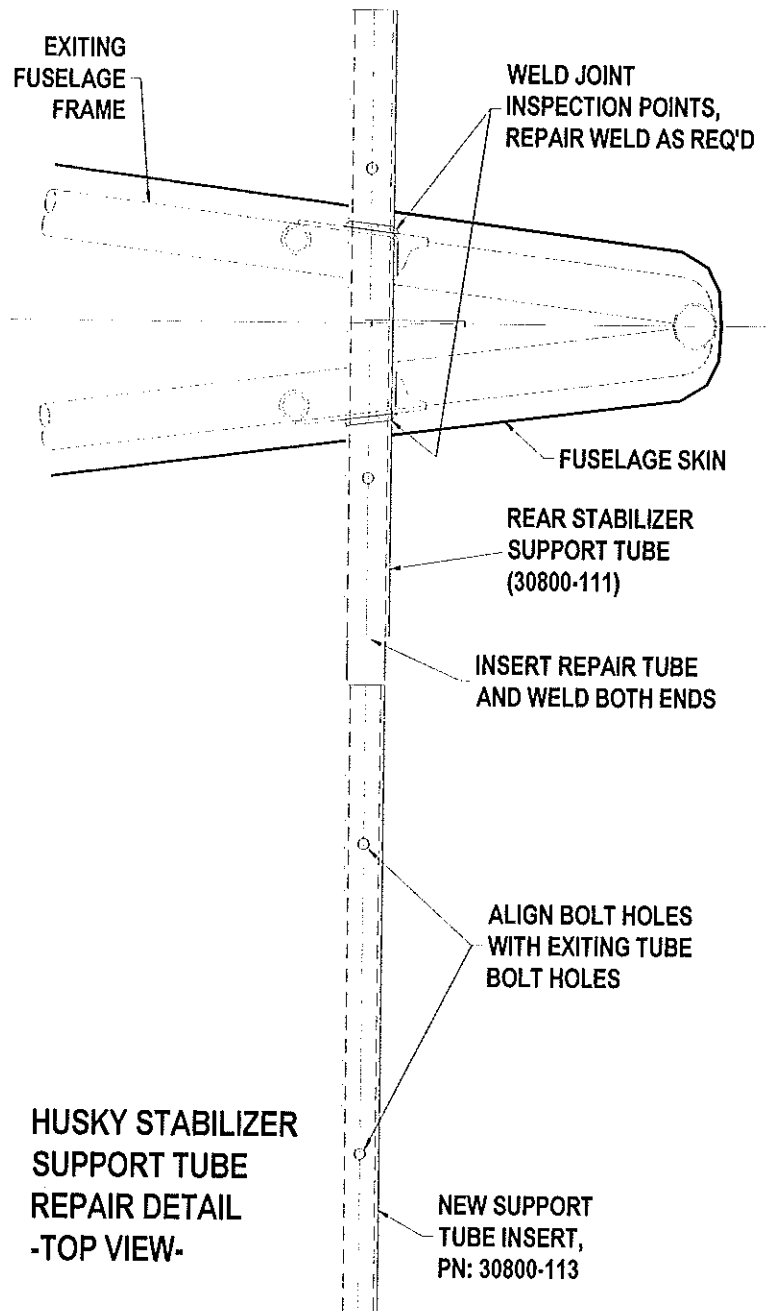
The **Rear Stabilizer Support Tube**, part number **30800-111** (All S/N's), will be superseded by new part number **35001-113** in new production aircraft. This action is due to reported incidents of Stabilizer Support Tube failure.

- e. Fabricate an insert repair tube using steel tube per the dimensions shown above. Drill stabilizer bolt attachment holes to match holes of existing support tube. Refer to repair detail below.

- f. Insert repair tube inside existing stabilizer support tube, align bolt holes, and rosette weld both ends of the tubes together.
 - g. Perform repair weld to tube support plate on fuselage as required. Be sure tube is properly aligned to fuselage.
