SUBJECT: ENGINE EXHAUST MUFFLER INSPECTION

### AIRCRAFT MODELS AFFECTED: A-1, A-1A, A-1B, A-1C-180

### SERVICE BULLETIN NO. 35

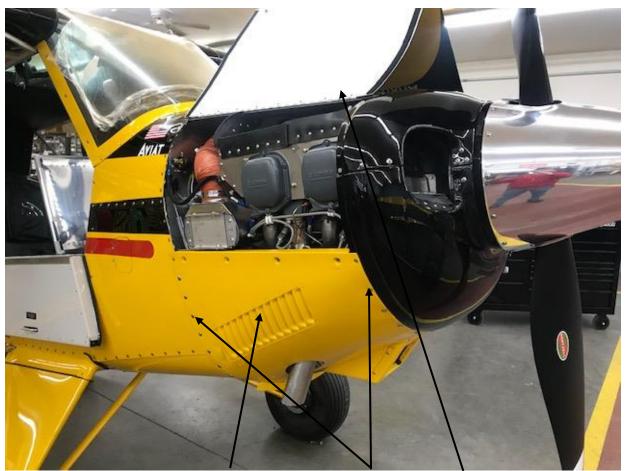
Figure 1: lower cowling, mounting screws, and cowl doors

Step 3. Remove the lower cowl assembly shown in Figure 1. To remove the lower cowling, start by opening the cowl doors and securing them out of the way as shown in figure 1.

Next remove the 4, AN507, countersunk screws in the four corners of the cowling and replace them with four #10 sheet metal holding devices such as clecos to hold the cowling in place while all screws are being removed.

Next remove all the AN526 pan head screws around the front and rear of the lower cowling. The AN526 pan head screws securing the lower cowling on the front and rear are of two different lengths and should be separated to assure correct reassembly.

While holding the lower cowling in place, remove the sheet metal holding devices or clecos and the lower cowl can be removed by dropping it straight down.

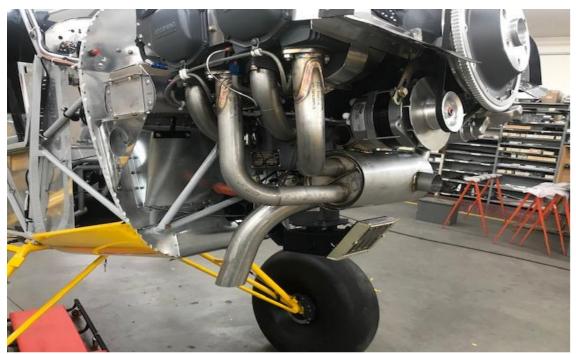
Figure 2: cowling removed

Step 4. Remove the exhaust system. With the lower cowling removed the exhaust system can be seen in Figure 2. To remove the exhaust system, start by locating and removing the two scat hoses attached to the exhaust as shown in Figure 3.

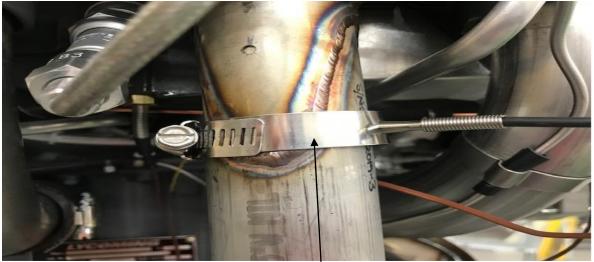
Figure 4, EGT probe

Step 5. Remove the EGT probe or probes from the exhaust manifold tube on number 3 cylinder, see Figure 4. Depending on aircraft options, all four exhaust manifold tubes can have EGT probes installed. Tie up the EGT probes and wiring out of the way, for ease in removal of the exhaust system.

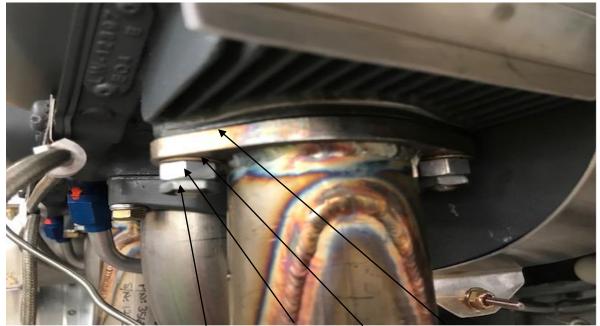
Figure 5, lock nuts, mounting nuts, washers, & exhaust gasket

Step 6. Remove the lock nuts from the 8 engine studs. Next remove the mounting nuts, two each, from each exhaust manifold tube (see Figure 5). The exhaust system should be held in place while the mounting nuts are being removed. Once the EGT probes and the mounting hardware are removed, the exhaust system can be removed by dropping it straight down with the manifold tubes still inserted on the muffler assembly. When the exhaust system is removed, discard the used exhaust gaskets.

Verify new exhaust gaskets are in place and install the exhaust using the plain nuts that were removed from the manifold tubes. See Figure 5. The AN936A516 lock washers that were removed must be replaced by new ones and installed before the nuts. The nuts holding the manifold tubes must be torqued to 160 inch-lbs. Next install the 5/16-18 pal nuts. Pal nuts are used as a locking device and must be torqued to 52 inch-lbs. after installation. See Figure 11. Install EGT probes in reverse order as removed.

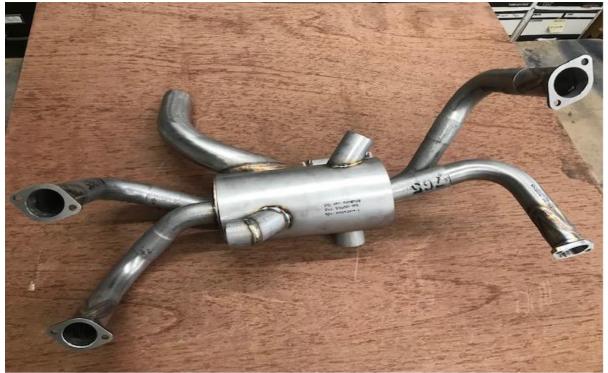
Figure 6: removed exhaust assembly

Step 7. Remove the exhaust assembly from the aircraft and place it on a bench for inspection as shown in Figure 6. Next, remove manifold tubes & shroud to expose the exhaust can as shown in Figure 7.

Next install the manifold tube into the slip joints on the muffler using a high temperature anti-seize lubricant such as Loctite C5-A. The anti-seize lubricant should be applied to the first 2 inches of the manifold tube before installing into the muffler assembly. With the shroud installed and the manifold tubes inserted into the muffler as seen in Figure 6, the exhaust can now be installed on the engine.

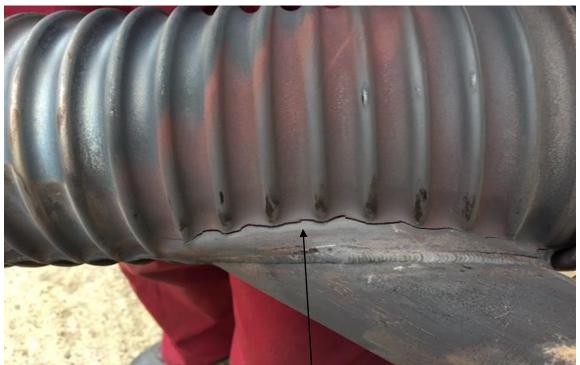
Step 8. Using the "Instructions for Continued Airworthiness" applicable to each aircraft model, inspect the muffler assembly. In addition to the required inspections listed in the "Instructions for Continued Airworthiness", inspect the muffler assembly for signs of cracks and / or leaks. We recommend the use of (AC) 91-59-A, Inspection and Care of General Aviation Exhaust Systems, for performing this inspection. Sections 6b and 6c should be referenced for specifics of inspection. Signs of an exhaust leak include a flat gray, gray-white, or light gray powder or a sooty appearance on surfaces. Inspect the scat tube on the back of the shroud for signs of exhaust leaking into the cabin heater. See Figure 3. If exhaust residue is found in the scat tube, an exhaust leak is present that must be found and corrected. Typical cracks reported from the field were found on the muffler assembly around the base of the tailpipe and on the ridges as shown in Figures 8, 9, and 10.

Figure 10, muffler crack

Step 11. The severity of the crack or cracks found during inspection will determine if a repair is applicable or if replacement is necessary. Cracks found at the base of the muffler tail pipe as shown in Figure 8 are repairable. **Cracks in the muffler can on top of the ridges or bottom of the valleys as shown in Figure 9 are not repairable and the muffler must be replaced. A crack as shown in Figure 10 is too severe to repair and the muffler must be replaced.** The FAA certified mechanic or FAA certified repair station performing this inspection must determine the severity of the cracks and determine if a replacement muffler is necessary.

Mufflers needing repairs, should be sent to an FAA certified repair station for repair and testing. Make welding repairs in accordance with AC 43.13-1 or an FAA-approved equivalent. The welding process is Tungsten Inert Gas (TIG). The muffler is made from 321 stainless steel and a 347-filler rod must be used for repairs. Pressure test the repaired muffler in accordance with AC 91-59A section 8c4.
