SUBJECT: Stabilizer Support Assembly

**REVISION: C**

**AIRCRAFT MODELS AFFECTED: A-1, A-1A, A-1B, A-1C-180 & A-1C-200**

"Inspect the stabilizer support assembly for cracks per paragraph (f) of AD 2020-16-06".

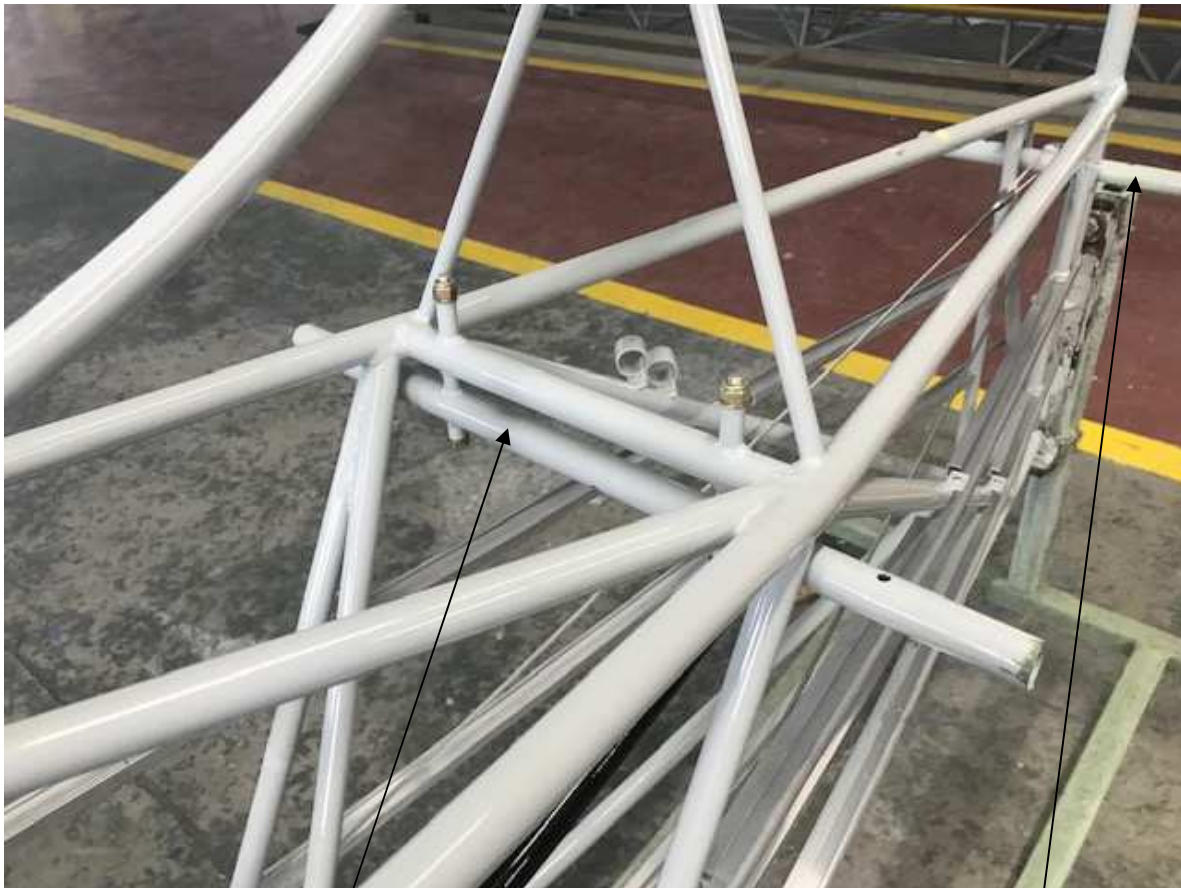
Figure 1, Stabilizer Support Assembly, fabric removed for clarity. Tube 30800-111

Step 2. Locate the stabilizer support assembly as shown in figure 1. The use of illustrated parts catalog (IPC) section on tail surface installation can be helpful with disassembly and reinstallation.

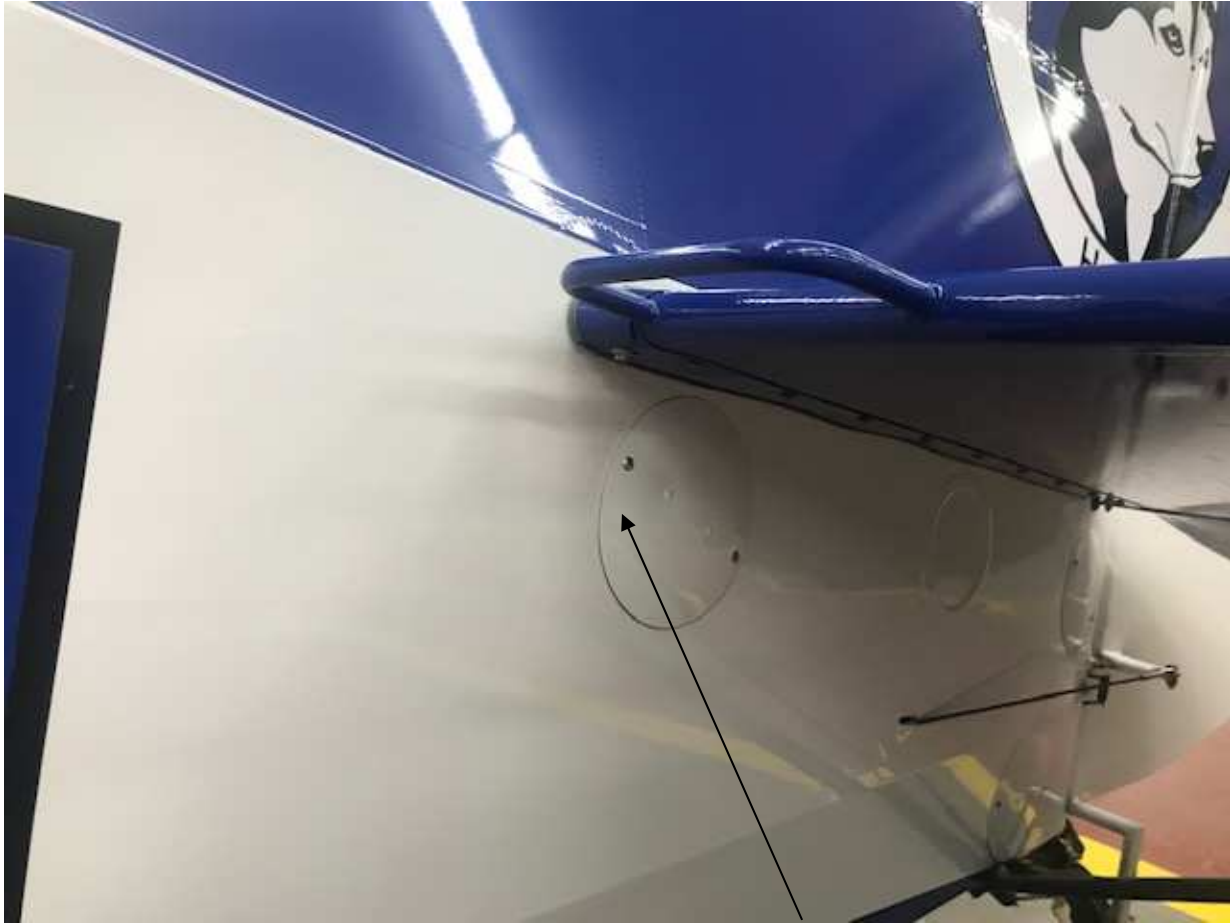
Figure 2, Inspection access hole cover LH side

Step 3. Remove adjacent inspection hole cover located just behind and below the horizontal stabilizer assembly leading edge. There are inspection holes on both right and left sides of the fuselage. Either hole can be used to gain access to the stabilizer support assembly. See figure 2.

To remove the hole cover, remove two PK screws and slide the hole cover forward to release the mounting tabs on the back side of the hole cover. With the hole cover removed you will have access to the stabilizer support assembly mounted to the fuselage.

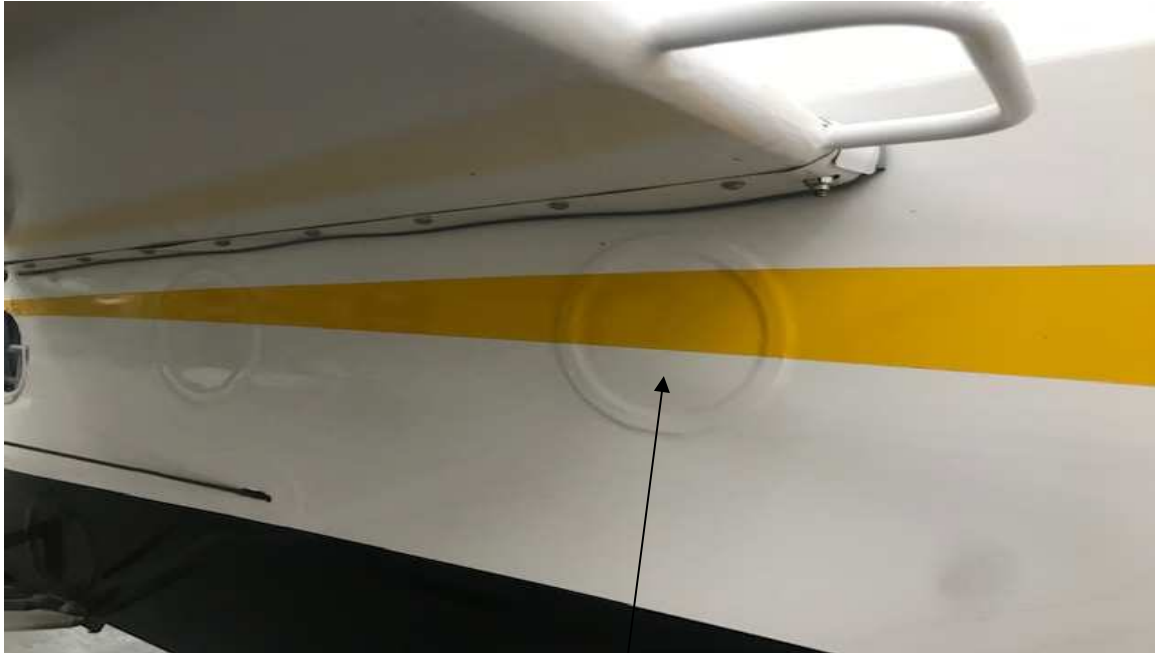
Figure 3 Uncut inspection ring

If the inspection ring is not cut out as shown in figure 3 then the inspection ring will need to be cut out to gain access to inspect the stabilizer support assembly.

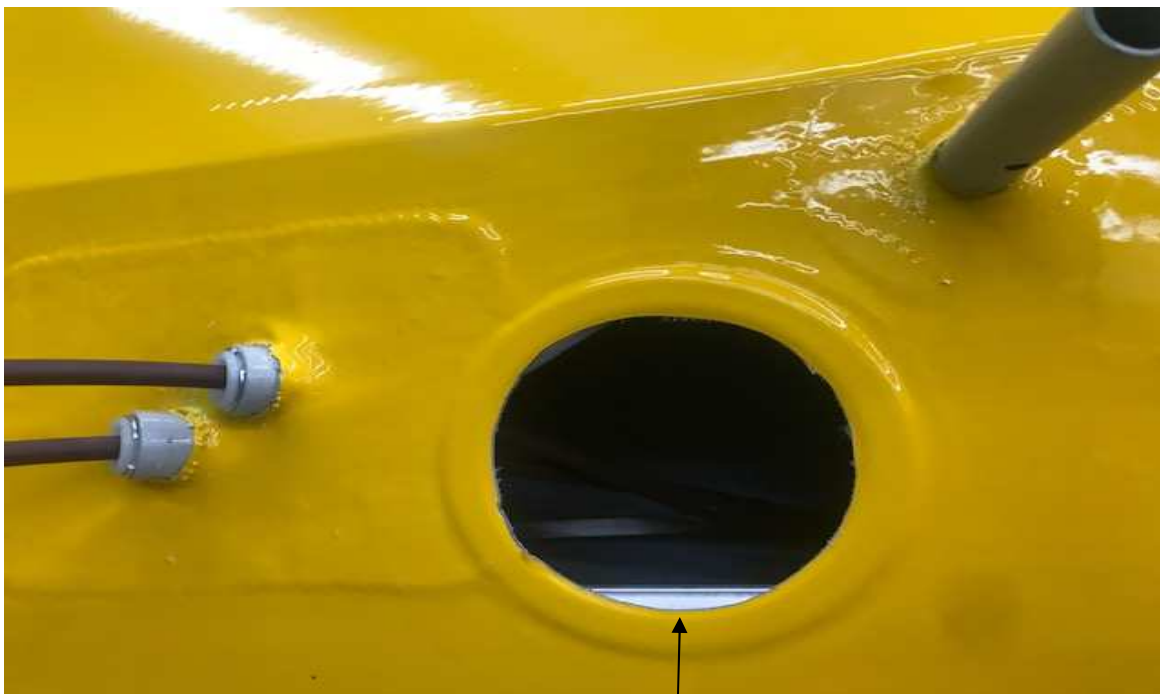
Figure 4, Cut out inspection ring

To cut out the inspection ring, use a sharp knife such as an exacto knife and cut out the inside portion of the inspection ring as shown in figure 4. An inspection hole cover P/N 61659 and mounting screws P/N 59146 x 2 can be purchased from Aviat Aircraft Inc.

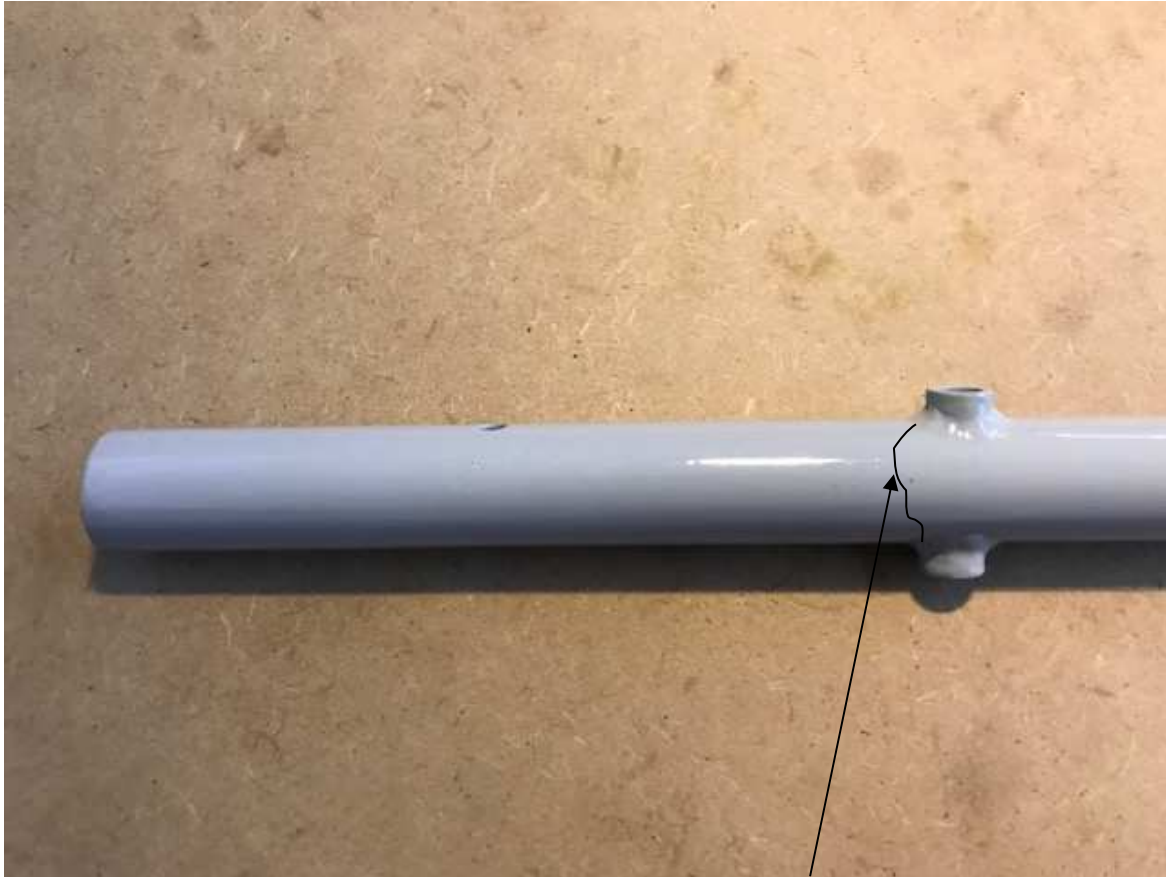
Figure 5, Typical crack location

Cracks reported originated at the toe of the welded bushings, see figure 5.

Inspect both the right end, left end, and the forward and rear sides of the stabilizer support assembly tube in the area shown in figure 5 for the presence of cracks.

If a broken or cracked stabilizer support assembly is discovered during this inspection, it must be replaced. The following pages of this service bulletin describes the removal and replacement of the stabilizer support assembly.

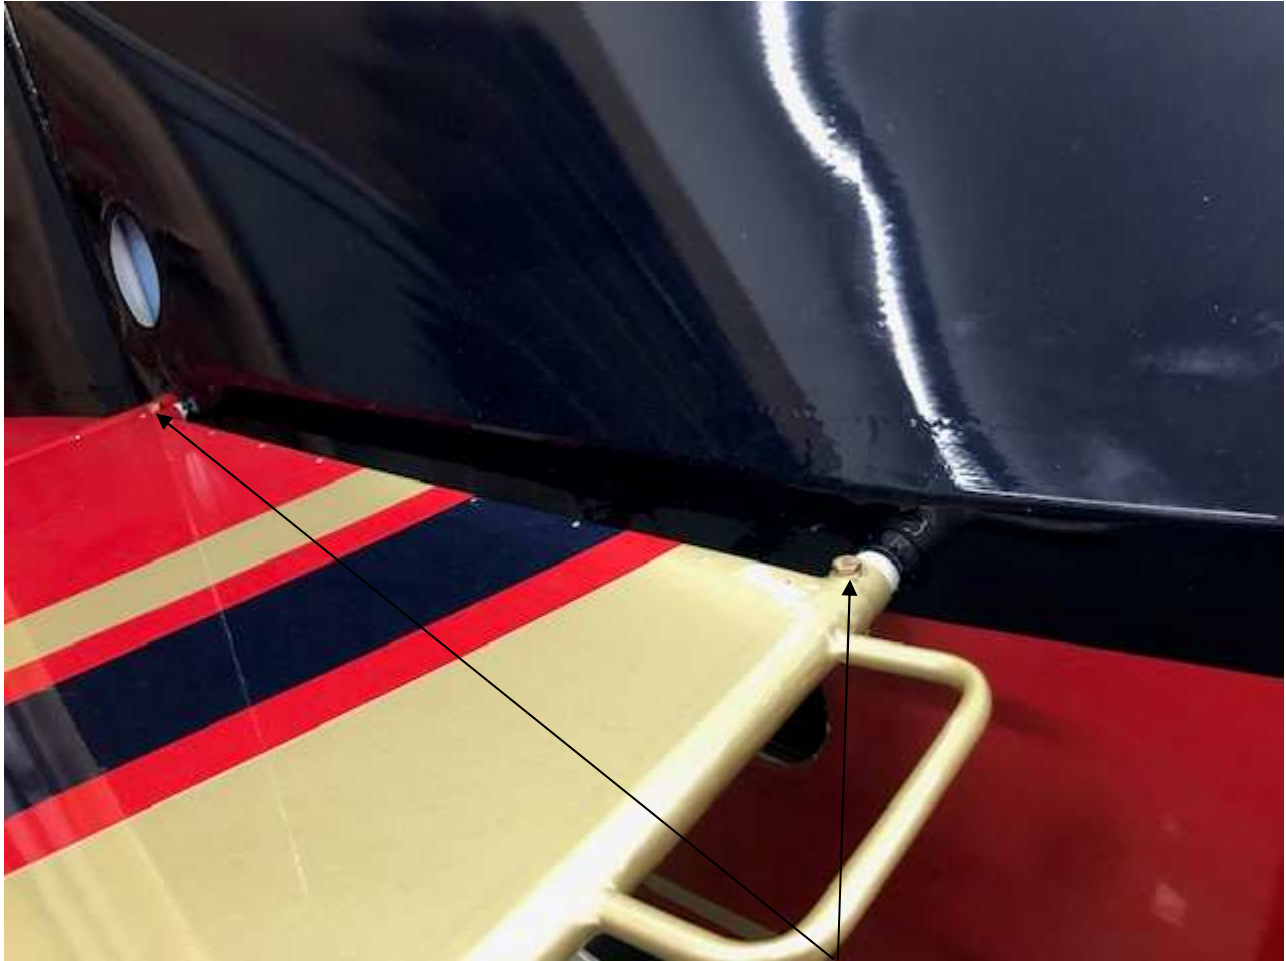
Figure 6, Tail fairings removed and AN3 attach bolts shown

Step 4. To replace a stabilizer support assembly, start by removing the stabilizer tail fairings. Horizontal stabilizer tail fairings are located on the top and the bottom of the horizontal stabilizers at the fuselage. See figure 6.

To remove the tail fairings top and bottom, remove the PK screws holding the fairings to the horizontal stabilizers.

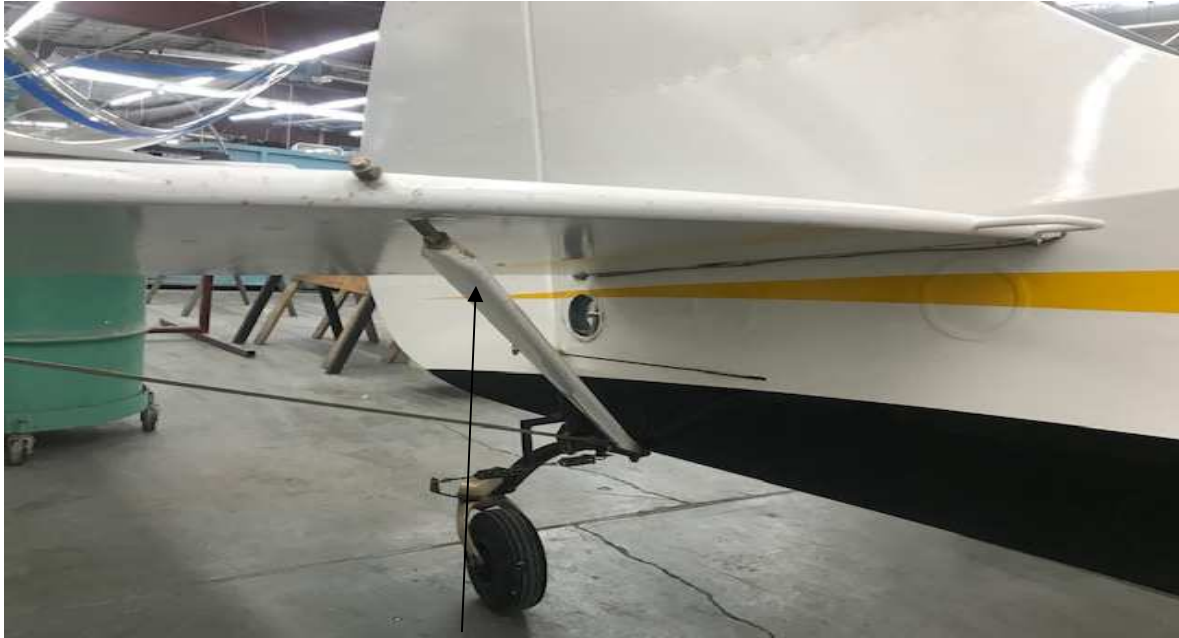
Figure 7, Stabilizer strut assembly

Next remove the stabilizer strut assemblies from the horizontal stabilizers and fuselage.

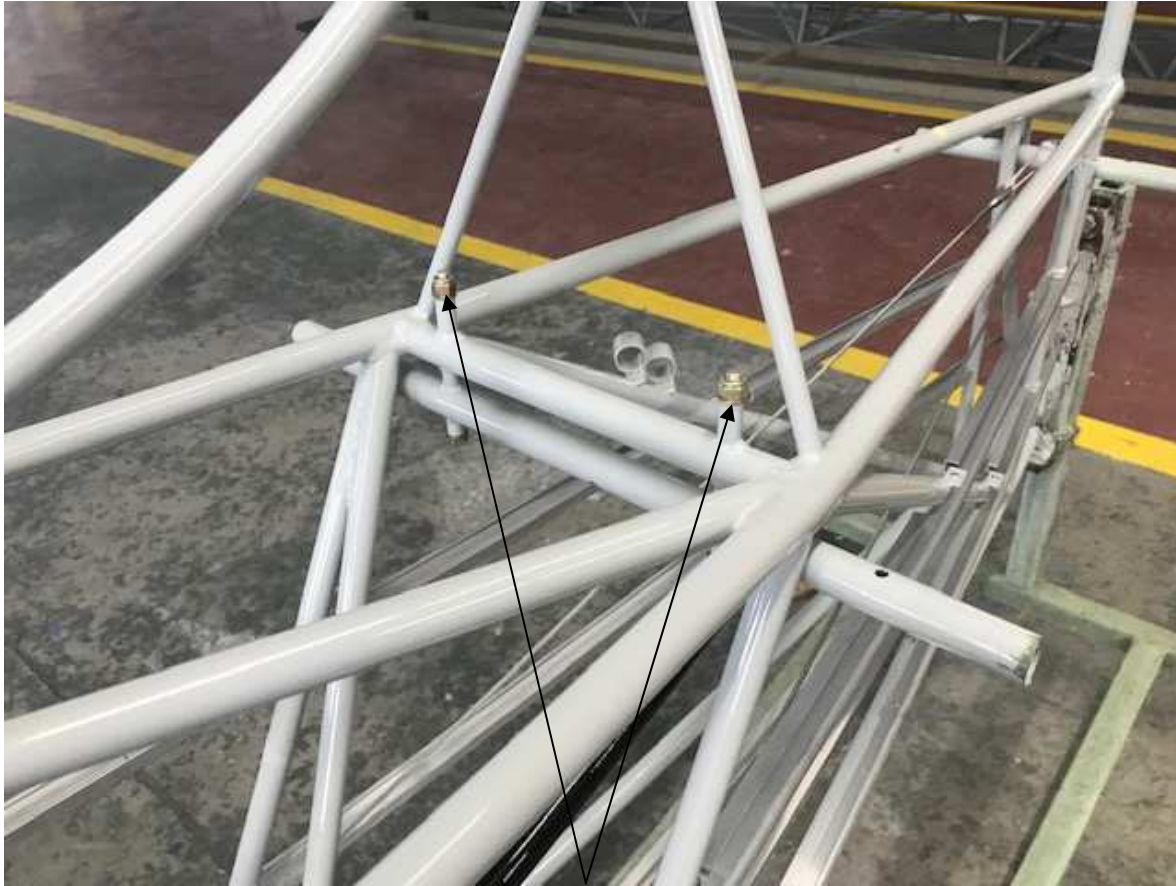
Figure 9, AN4 Bolts, fabric removed for clarity

Step 6. With the inspection hole cover opened, the horizontal stabilizers taken off and the elevators supported, remove the two AN4 bolts attaching the stabilizer support assembly to the fuselage. See figure 9.

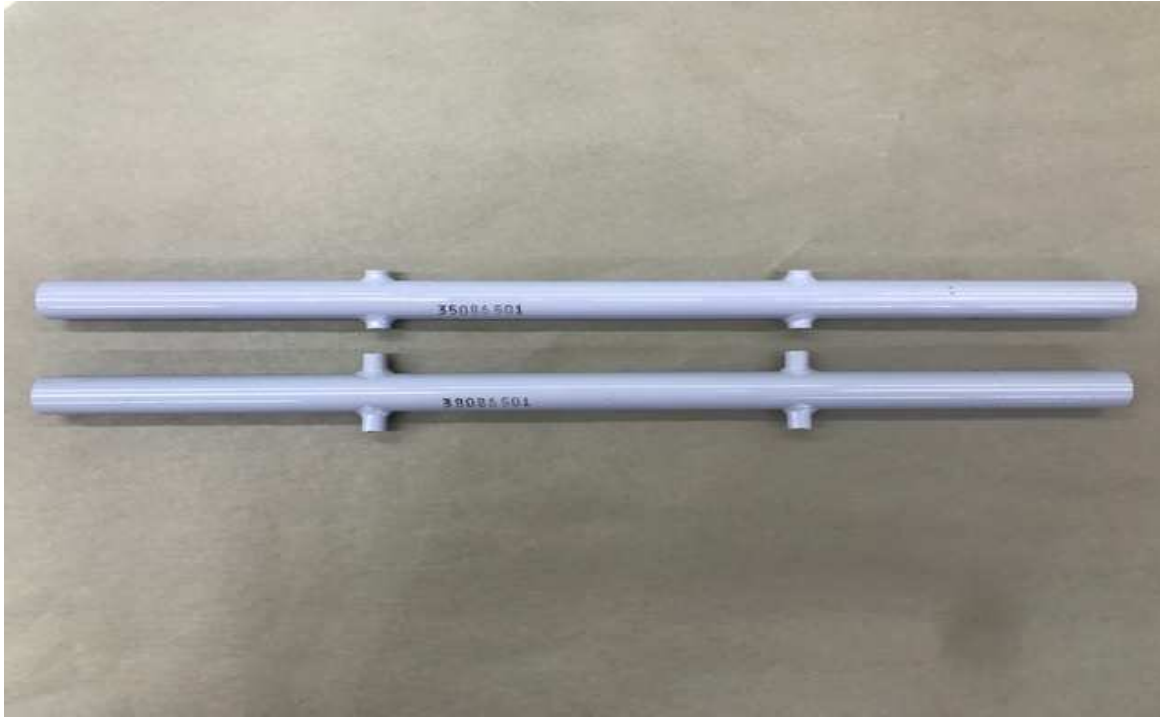
Figure 10, Stabilizer Support Assemblies

Step 7. Once the stabilizer support assembly is removed verify the P/N as 35086-501 or 38086-501 located on each assembly. See figure 10. The stabilizer support assembly must be replaced with the same P/N as the removed assembly.

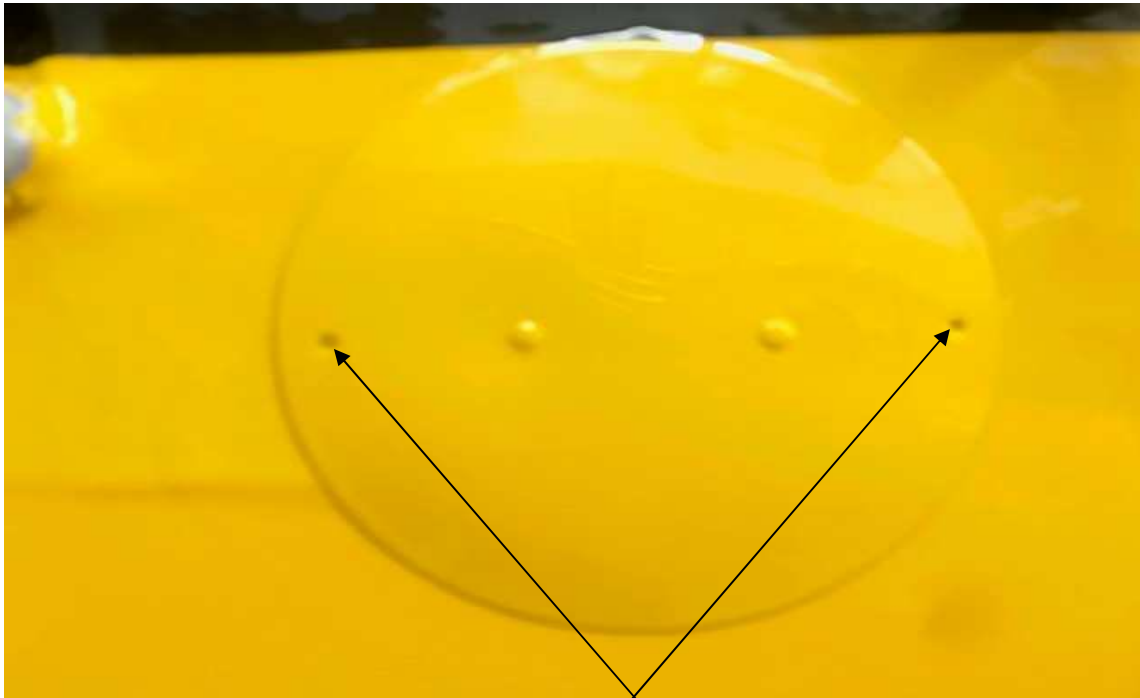
Figure 12, mounting holes

Next place the other mounting tab behind the fabric and slide the hole cover until it centers over cut out inspection hole. See figure 12.

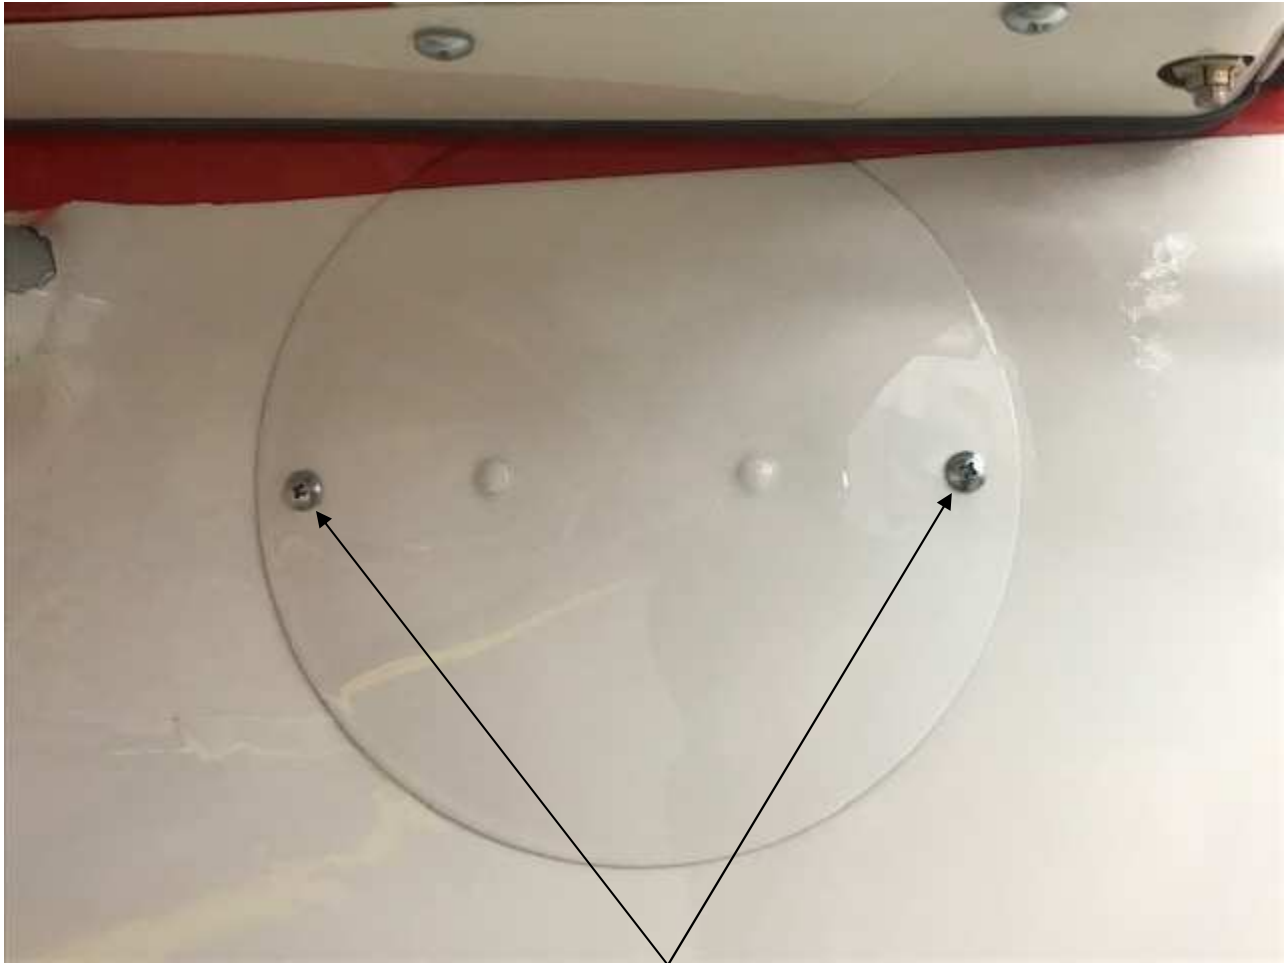
Figure 13, PK screws installed

Using a # 40 drill bit, drill in the existing two holes in the hole cover, drill through the fabric and install two PK screws. See figure 13. If there is any question about installation of a hole cover refer to one of the other installed hole covers for reference.
