SUBJECT: FUSELAGE TUBE INSPECTION

**AIRCRAFT MODELS AFFECTED: A-1, A-1A, A-1B, A-1C-180, & A-1C-200**

In the interest of safety and to be proactive concerning possible tube failures, Aviat Aircraft Inc. is issuing this Mandatory Service Bulletin requiring tube inspections.

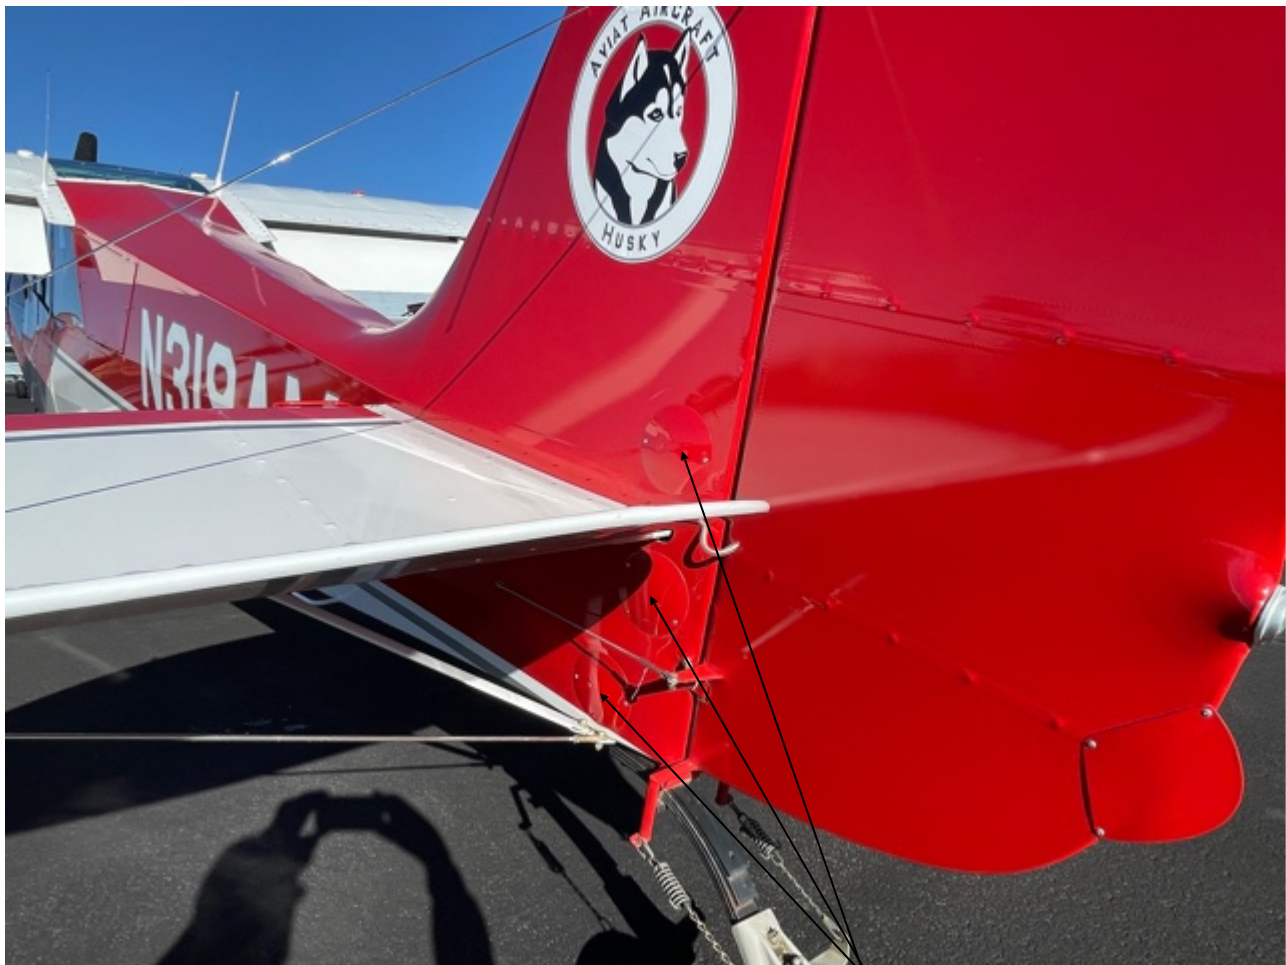
Step 1. On the empennage section of the fuselage locate the inspection covers on the LH and RH sides located just above and below the elevator/stabilizer hinge line, see figure 1.

Figure 1, inspection covers LH side

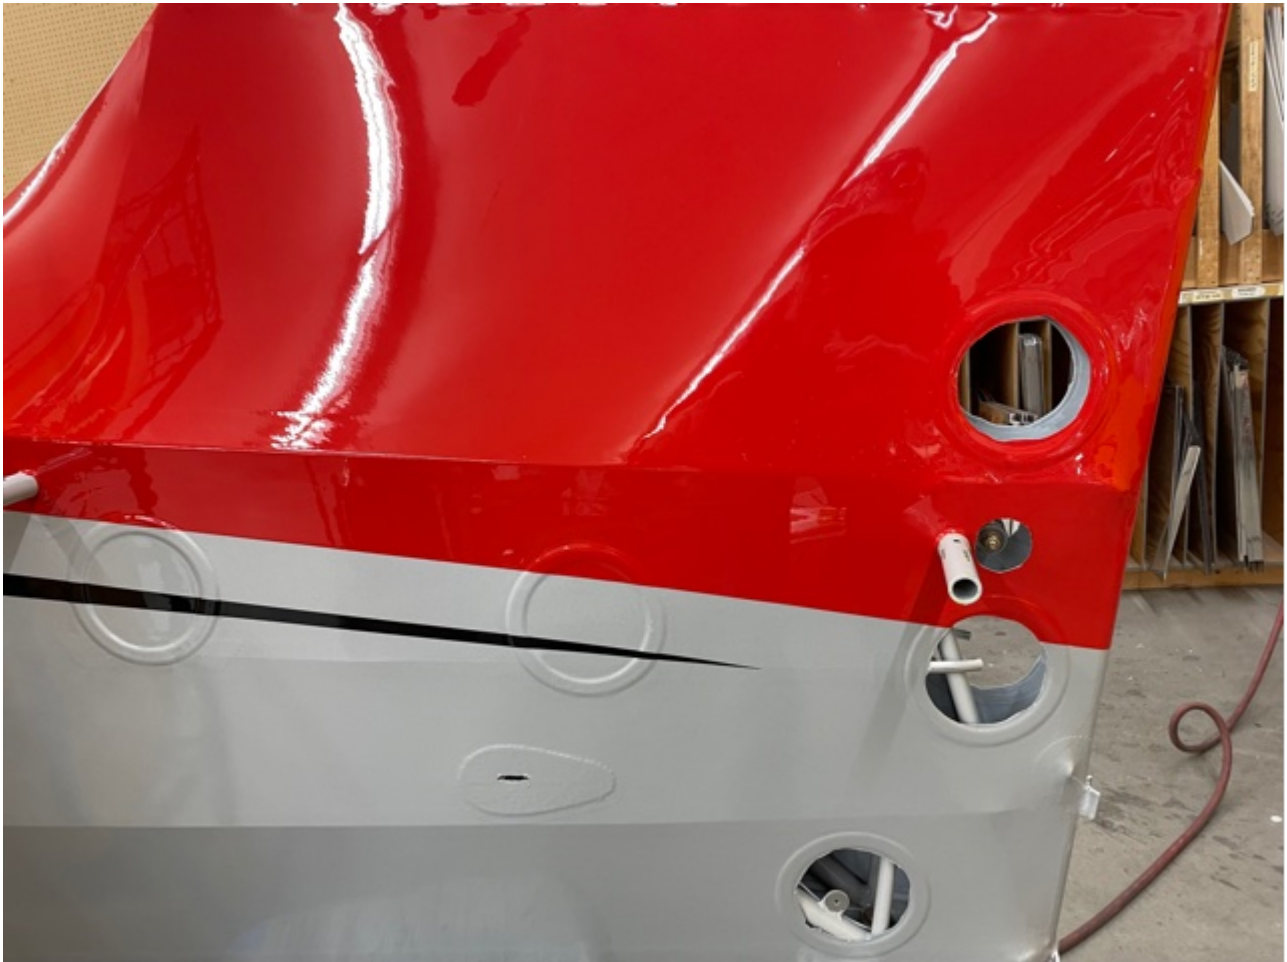
Figure 2, elevator, and stabilizer removed for clarity

Step 2. Remove the hole covers, remove two screws in each hole cover then move the hole cover forward to release the spring steel tab behind the fabric. With the hole covers removed, see figure 2, you will have access to the tubular structure of the fuselage.

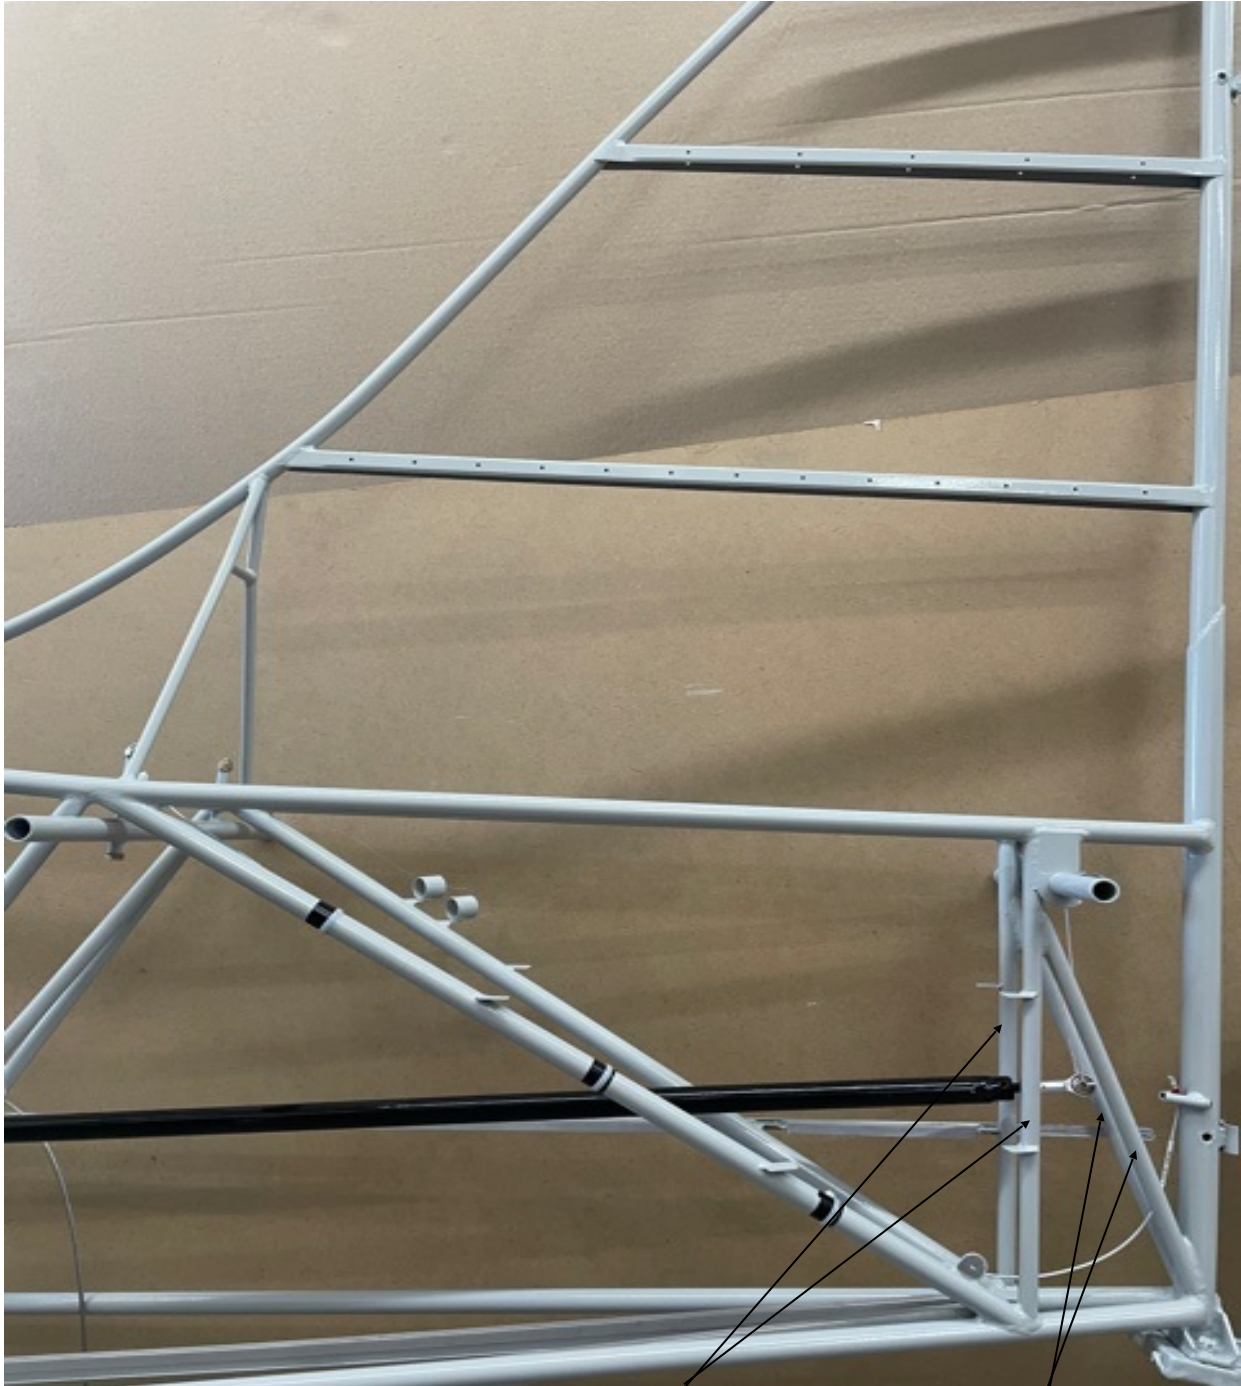
Step 3. Locate tubes, part numbers 35001-071, 35001-072, 35001-033, & 35001-034. See figure 3. The use of the applicable illustrated parts catalog (IPC) can be helpful to locate the applicable tubes. In the IPC, see section 6, Fuselage Structure, items no. 61 & 63.

Step 4. With the tubes located, the inspection of the tubes can begin. Using a light and a mirror, or other suitable methods, inspect the tubes from top to the bottom for any cracks or breaks. Pay particular attention around welds at the tops and bottoms of the tubes.

Figure 3, no fabric for clarity. Tubes 35001-071 & -072 / 35001-033 & -034

If cracks or breaks are found during the inspection, contact Aviat Aircraft Inc. engineering department for further instructions.
