SERVICE BULLETIN NO. 4

1. APPLICABILITY: ACCOMPLISIEMENT OF THIS SERVICE BULLETIN IS MANDATORY, PRIOR TO 21 MAY, 1972. This service bulletin applies to all Pitts Aviation Enterprises Model S-2A airplanes from serial no. 2001 through and including serial no. 2022. (This change on airplanes serial no. 2023 & up will be accomplished at the factory.)

SERVICE BULLETIN NO. 4
(MANDATORY)

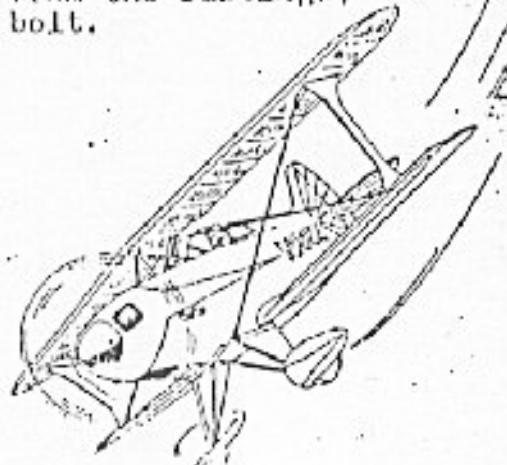
2. PURPOSE: To preclude failure of the horizontal stabilizer lower brace wire attachment to the fuselage.
3. DISCUSSION: A failure of the part no. 2-2117-1 "strap-stabilizer brace" has been brought to our attention. The failure occurred at the weld of the strap to the fuselage lower longeron. Although we believe this occurrence to have been an isolated case, we are making the following change mandatory.

4. ACCOMPLISH THE FOLLOWING: (Refer to Fig. 1.)
 - a. Chock the main wheels of the airplane.
 - b. Support the aft fuselage of the airplane approximately six inches forward of the tailspring forward attaching bolt. (Note that the tailwheel assembly must not be supporting any load.)

- c. Loosen until free the two AN 4-16 bolts holding the tailspring to the finpost.
 - d. Remove the access cover on the side of the aft fuselage giving access to the forward tailspring attach bolt (AN 6-21).

- e. Loosen the two lower stabilizer brace wires (AN 674, 31 inches long) and remove the hardware at the lower ends of these wires at the fuselage: AN 380-2-2 cotter pin and AN 394-15 clevis pin.

- f. Loosen the tailspring assembly from the fuselage, discarding the AN 6-21 forward bolt.

- g. Cut off the two tabs on the existing 2-2117-1 strap as close to the fuselage longerons as convenient.
Note: 1. Do not damage the longerons;
2. The upward-sloping portion of the tab must be removed completely;

- i. Run up snug but do not tighten all three tailspring bolts.
 - j. Re-attach the two An 67⁴ wire lower ends to the 2-2117-1A lugs, using the same hardware as step (e) above with a new cotter pin, and re-tighten the wires, to the same tension as before they were loosened in step (e) above.
