# **PITTS** AVIATION ENTERPRISES, Inc.

## SERVICE BULLETIN NO. 5

2. PURPOSE: To prevent structural damage arising from in-flight vibration of the upper and lower aileron interconnect tubes; Pitts P/N 2-5216-1.
3. DISCUSSION: There have been reports of some airplanes in the above-noted serial number range which have experienced in-flight vibration of the aileron interconnect tubes. In addition, there has been one case in which the vibration was severe enough to cause a structural failure of the attachment at the lower aileron end of the tube. (This airplane remained fully controllable, and was safely landed without further damage.) Since learning that some aircraft have experienced this vibration, extensive investigation by Pitts Aviation Enterprises, Inc. and Aerotek, Inc., including in-flight studies, has revealed the following information:

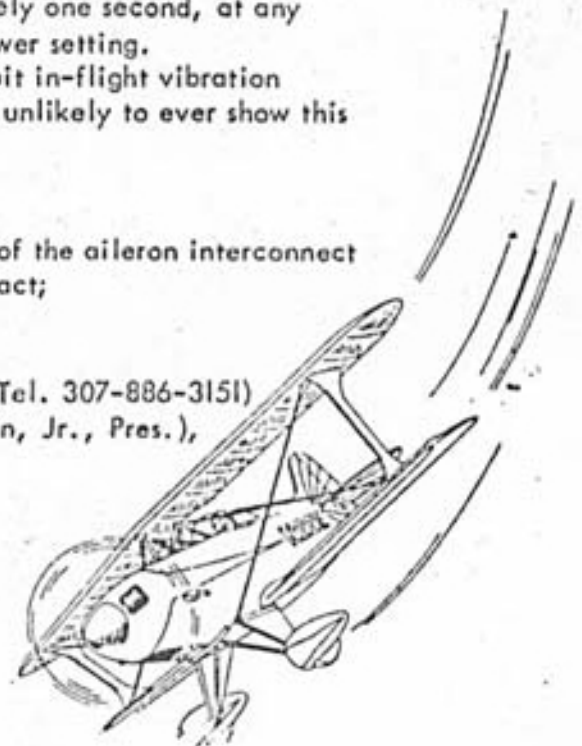
and arrange for immediate shipment of two replacement aileron interconnect tubes, part no. 2-5216-11, (3/4 x .035 round tube, 4130 'N'). Send the original tubes to Aerotek, Inc. Note: If your airplane has exhibited the above noted in-flight vibration, it is recommended that you do not fly until installation of the replacement tubes is accomplished.

- b) When installing the replacement tubes, make certain to adjust the length at the lower threaded end to the same overall length between AN3 bolt centers as the tubes originally installed on your airplane. Also note that the same installation hardware at the upper and lower ends of the tubes may be retained for re-use, but make certain that the correct number of AN960-10 (1/16 or 1/32 thick) washers are installed so that the bearing inner races are clamped-up snugly without bending the fork ends of the tubes.
- c) Whether or not your airplane has exhibited the adverse vibration of the aileron interconnect tubes noted in this Bulletin, please execute the enclosed compliance card and mail to:
