No: 000255

Send To: 902 LOWER WING KIT

U
S
TSubject: CLARIFICATION OF WOOD
GRAIN DESCRIPTION IN
PREVIOUS PRODUCT LETTER
000252 DATED 02-16-82

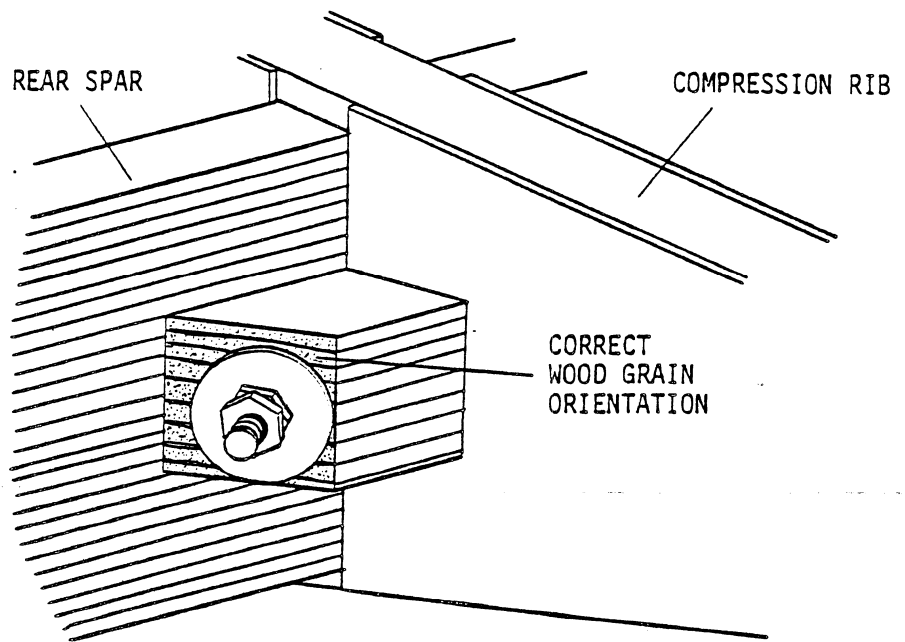
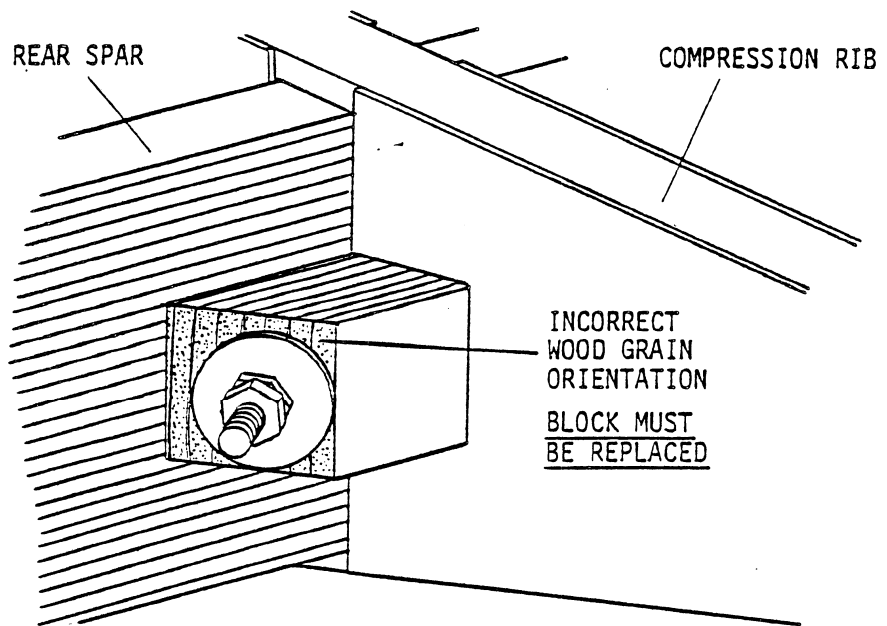
ENCLOSURES: Engineering Sketch X-90147

The subject product letter requested inspection of the direction of wood grain on the tierod blocks located on the rear spars of the upper and lower wings of the Eagle II aircraft. The phrase "perpendicular to the spar face" has caused much confusion. In response to many telephone calls requesting clarification of the grain direction requirement we have prepared Engineering Sketch X-90147 which illustrates the correct and incorrect grain directions.

It is unlikely that any blocks with incorrect grain were supplied to any Eagle builder, but one incorrect block was found on a Christen factory demonstrator aircraft, and this requires that inspection of the blocks be performed on all kits and completed aircraft.
