PITTS AVIATION ENTERPRISES, Inc.

MODEL S-2A

SERVICE LETTER NO. 3

Subject: Inspection of upper wing front spar to cabane fitting, P/N 2-4123

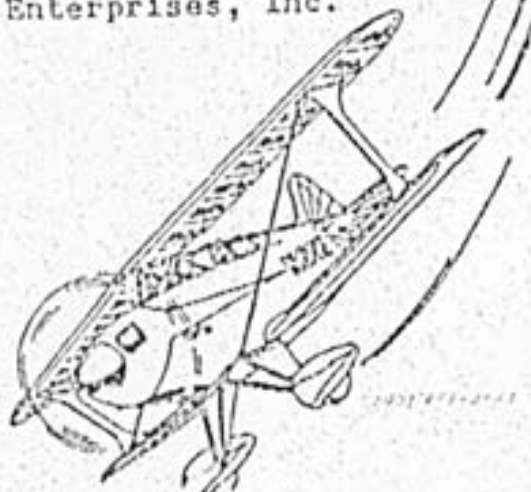
In order to accomplish the inspection, it will be necessary to remove all paint and fabric on the fittings below the wing lower surface contour. (Removal of the AN5 bolt is not necessary.) Inspect the front and back faces of both fittings for cracks, especially in the area immediately above the AN5 bolt at the lower end of the fitting. Dye-penetrant and/ or a ten-power glass may be used.

If cracks are noted, replace these fittings before further flight. If no cracks are present, re-finish bare metal surfaces exposed for the inspection.
