# PITTS AVIATION ENTERPRISES, Inc.

Service Letter No. 5

PITTS MODEL S-2A AIRPLANE

PURPOSE: To check for cracks in the P/N 2-5100 control tube assembly.

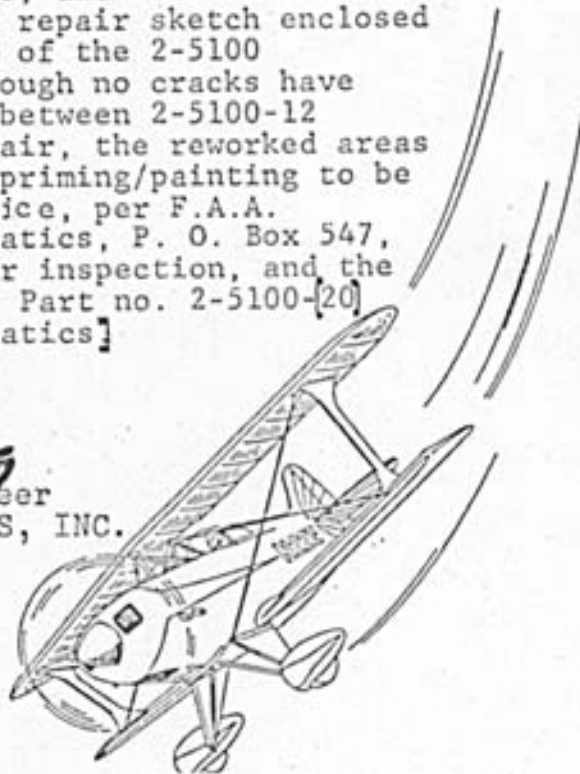
DISCUSSION: We have had a few reports involving airplane subject to frequent and vigorous aerobatics concerning cracks initiating at the junction of the aft. 2-5100-12 stick housing, where it is welded to the 2-5100-11 tube. (The 2-5100 control tube assembly connects the front and rear control sticks.) It is reported that having started, the cracks progress slowly.

ACCOMPLISH THE FOLLOWING: This area is easily inspectable without removal or disassembly of parts. Strip paint from the suspect region and inspect for cracks using a ten-power magnifier. If no cracks are noted, repaint the stripped area and repeat this inspection each 100 flight hours. If cracks are noted, remove the 2-5100 control tube assembly from the airplane, weld shut the cracks, and weld on reinforcing gusset, P/N 2-5100-[20], per repair sketch enclosed with this letter. Note that both ends of the 2-5100 control tube should be inspected, although no cracks have been reported at the forward junction between 2-5100-12 housing and 2-5100-11 tube. After repair, the reworked areas should be repainted. All welding and priming/painting to be in accordance with good aircraft practice, per F.A.A. AC 43.13.1. Please advise [Pitts Aerobatics, P. O. Box 547, Afton, WY.83110], of the results of your inspection, and the total airframe time on your airplane. Part no. 2-5100-[20] gussets are available from [Pitts Aerobatics]
